## **CITY OF TEMPE, ARIZONA - ADA TRANSITION PLAN**

### **Summary of Findings**

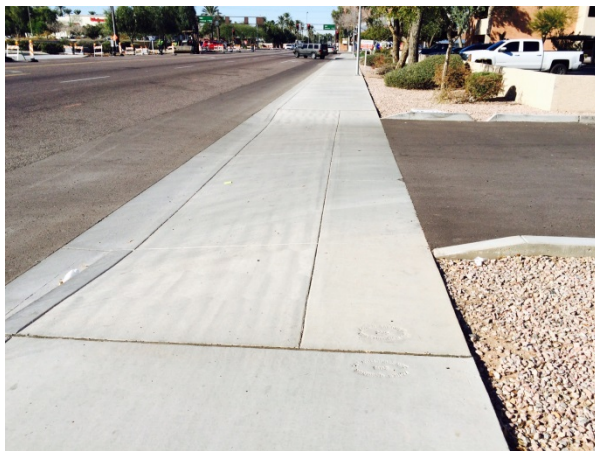
- Sidewalk Cross Slopes: 10.6 miles of sidewalk have cross slopes that exceed the 2% maximum. The majority of the cross slope violations are only slightly above the 2% maximum.
- Driveway crossings: cross slopes of driveway crossings often exceeded the 2% maximum. 455 individual driveways locations have cross slopes that exceed the maximum cross slope limit. The majority of driveways with cross slope issues, predate ADA guidelines.

*Figure 1: Accessible path behind driveway*

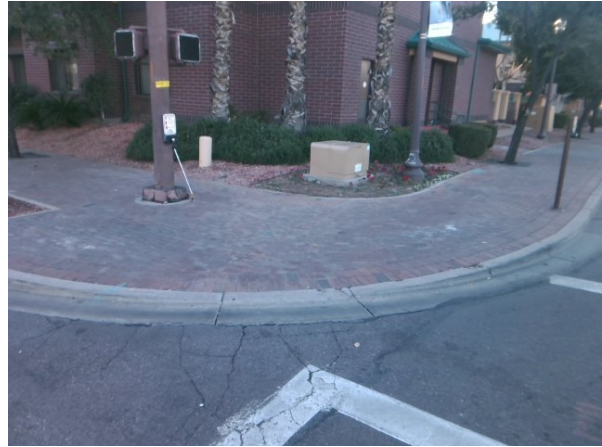
- Non-compliant curb ramps: ramps had non-compliant or missing landings or missing detectable warning systems (truncated domes).
- No Ramps: there are various locations where a curb ramp is warranted but none is present.

Figure 3: Install Detectable Warning System

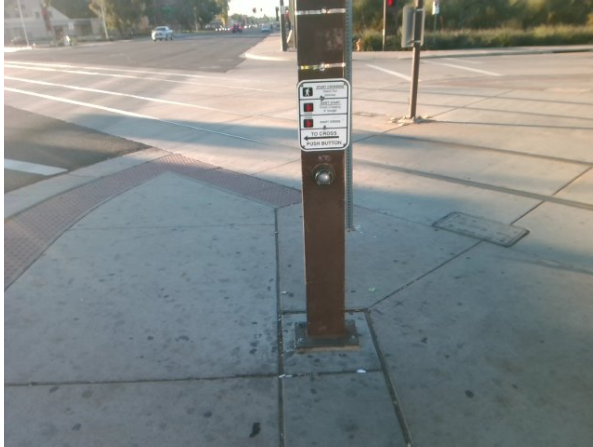
- Many of the pedestrian pushbutton locations had clear floor space slopes that exceeded the maximum allowable slope of 2%
- Several pushbutton locations were outside the MUTCD limits when measuring the distance to the curb and from the crosswalk.

Figure 4: Pedestrian Push Button

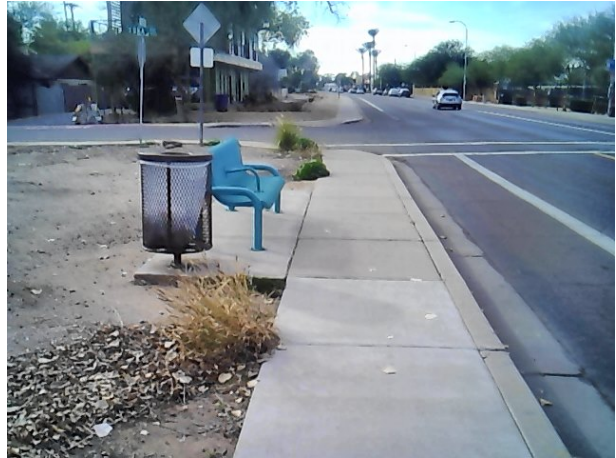
- Bus stop landing pad: the landing pad adjacent to the curb was either too small or had cross slope compliance issues.

Figure 5: Expand Bus Pad Landing

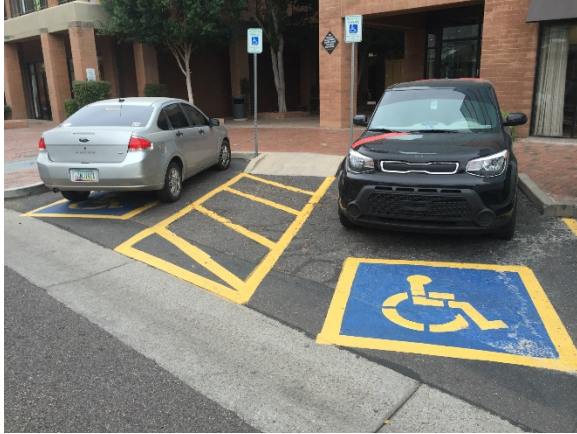
The accessible parking spaces provided at W. 3<sup>rd</sup> St. and at W. 4<sup>th</sup> Street are served by curb ramps that project into the accessible parking access aisle, which is not permitted.

*Figure 6: W. 3<sup>rd</sup> St. – Curb ramp within access aisle. 15% slope on curb ramp*

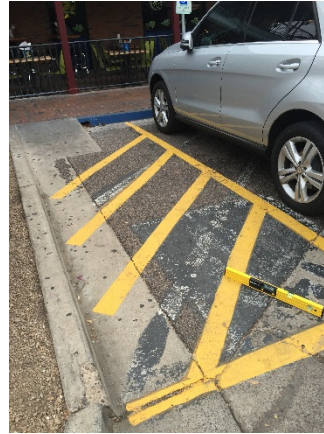
*Figure 7: W. 4<sup>th</sup> St. – Curb ramp within access aisle*

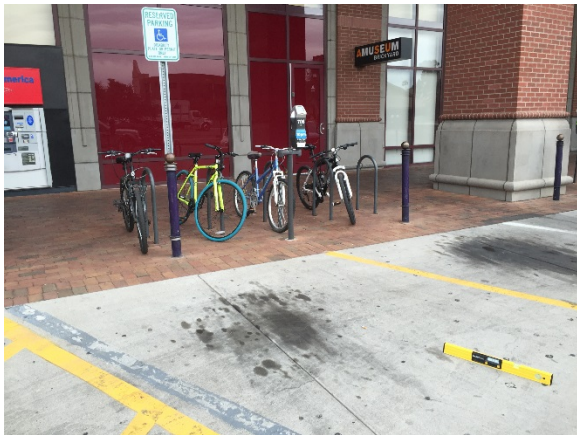
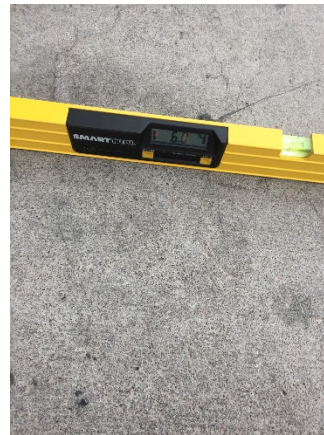
The accessible parking spaces along E. 7<sup>th</sup> Street have slopes within the parking spaces and aisles that exceed 1:48. The slopes range from 2.9% to 6.0%. Slopes within the accessible parking spaces and access aisles are required to be 1:48 (2.08%) in all directions for the full length and width of both areas.

*Figures 8 and 9: E. 7<sup>th</sup> St. – Slopes up to 6.0% within parking spaces*

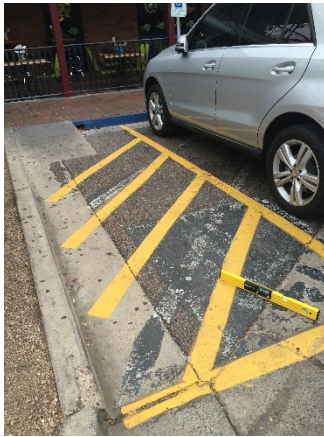
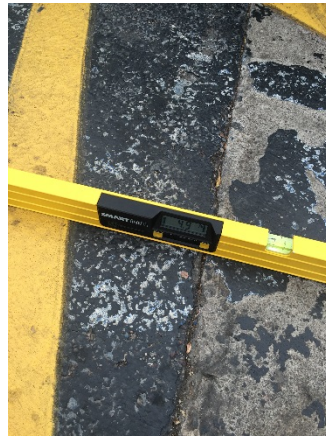
The accessible parking spaces at W. 4<sup>th</sup> Street have a 4.9% slope within the parking spaces and aisles where 1:48 maximum is required.

Figures 10 and 11: W. 4<sup>th</sup> St. – 4.9% slope within parking spaces

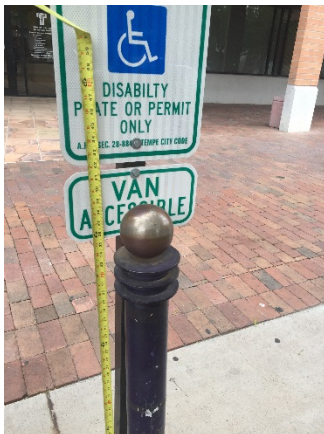
The accessible parking signs provided at the accessible parking spaces on E. 6<sup>th</sup> Street are too low. The signs are currently installed at approximately 36” above the parking surface where 60” minimum is required.

Figure 12: Parking signs too low.

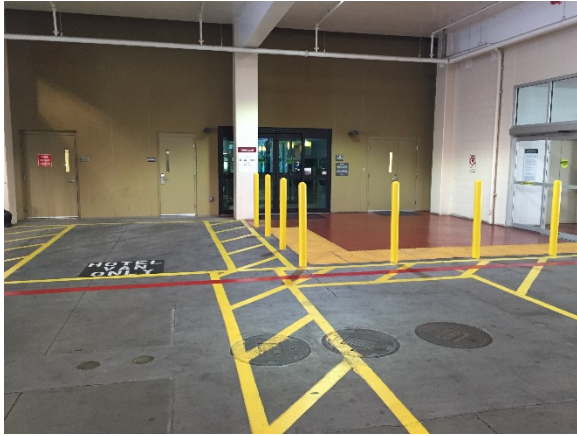
*Figure 13: “Hotel Van Only” is a closer space to the hotel entrance.*

The accessible parking within the City Hall garage parking structure is in substantial compliance except that it is recommend that one accessible parking space be relocated to the “hotel van only” parking space. This space provides a shorter route to the accessible hotel entrance.

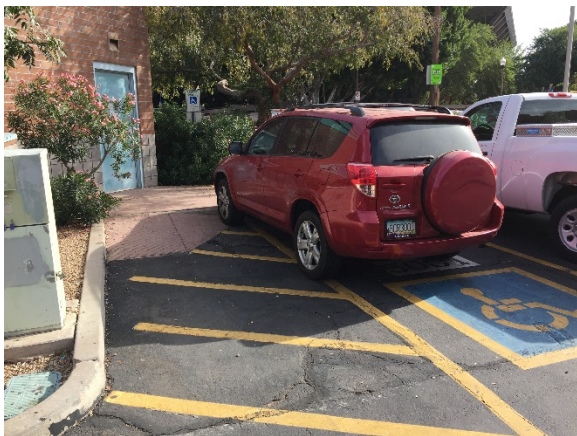
The existing accessible parking within this lot is not in substantial compliance. Issues include obstructed accessible parking signs and excessive slopes within the accessible parking spaces and aisles.

*Figure 14: City Hall West – Curb ramp within access aisle*

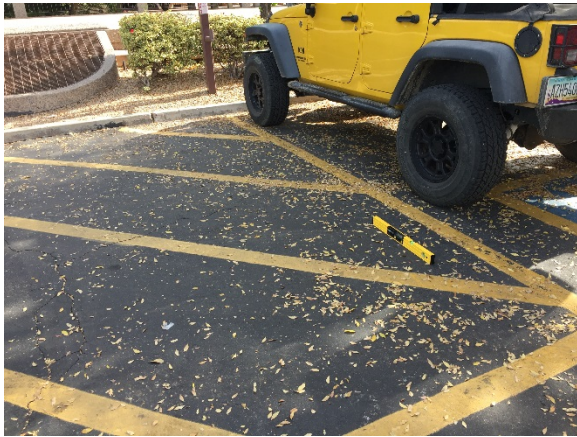
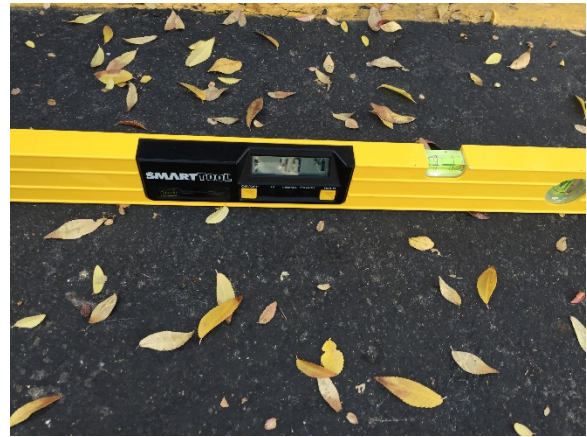
*Figures 15 and 16: City Hall West – 4.0% slope within space and aisle*

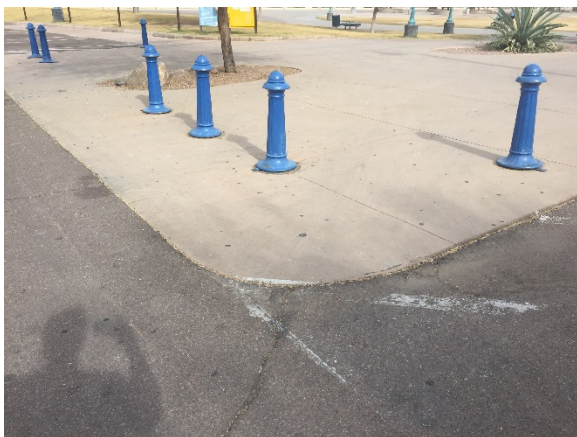
This parking lot is lacking one accessible parking space based on the total number of parking spaces provided. The existing accessible parking signs are too low at 43” and there is a non-compliant slope with the current van accessible parking space. The overhangs of vehicles parked at the sidewalk could potentially obstruct the clear width of the sidewalk. Wheel stops are recommended within these parking spaces. The sidewalk connection to the van accessible parking space includes a change in level greater than ½”.

*Figure 17: Change in level at access point*

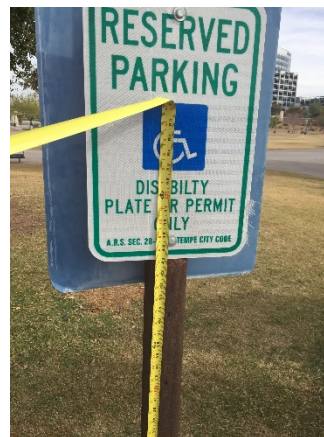
*Figure 18: Parking signs are too low.*

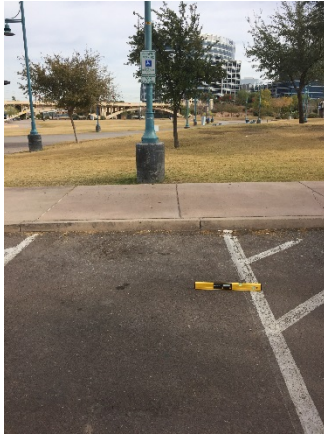
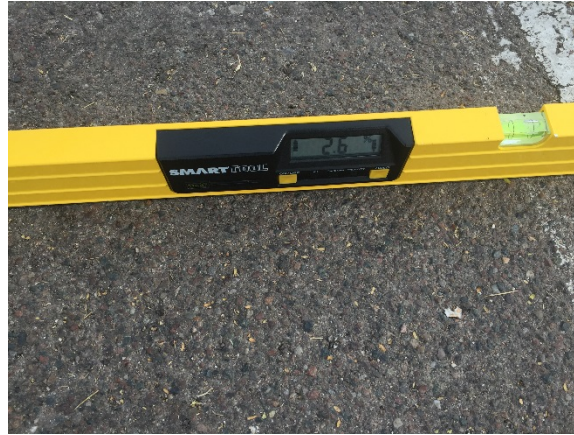
*Figures 19 and 20: Slopes greater than 1:48 within accessible parking*

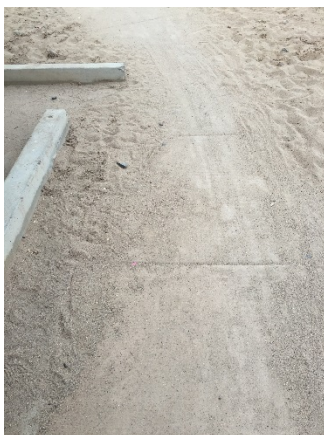
The accessible parking spaces are in substantial compliance; however, the connection between the asphalt parking surface and the sidewalk at the head of the spaces includes a level change greater than ½". Sand is constantly covering the sidewalk at the head of the spaces, creating a loose surface. The sidewalk is required to be maintained in an accessible condition. Stairs are provided from N. Mill Avenue that provide access to the lower level. No accessible pedestrian route is provided from N. Mill Avenue. An accessible route is required in the same general location as the general circulation route. Disabled pedestrians traveling north along N. Mill Avenue have no access to the lake edge.

*Figure 21: Sand covering accessible route*

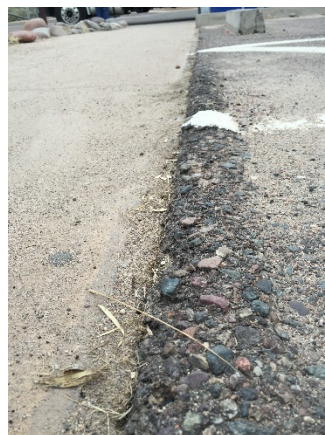
*Figure 22: Level change between parking and accessible route*

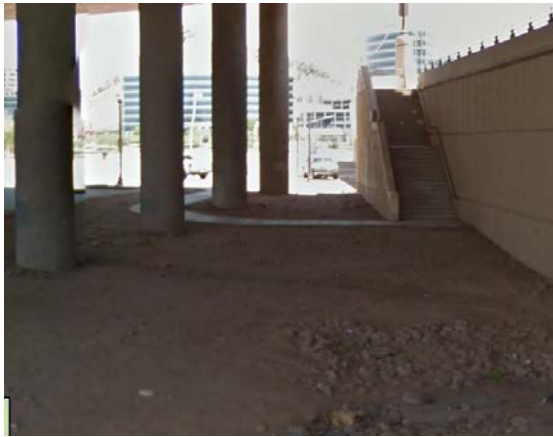
Figure 23: No accessible route from N. Mill Ave.

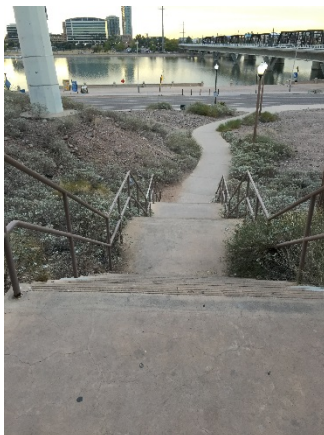
There is insufficient accessible parking spaces within this parking area. Signs are provided indicating that there is no accessible route to the lake edge from this level. However, there are stairs that provide direct pedestrian access to the lake edge. An accessible route is required in the same general location as the general circulation route. No accessible route is provided from the sidewalk along southbound N. Mill Avenue to the lake edge. Pedestrians without disabilities are able to utilize the stairs down to the lake edge and pedestrians with disabilities traveling south along N. Mill Avenue have no access the lake edge.

Figure 24: No accessible route to lake edge

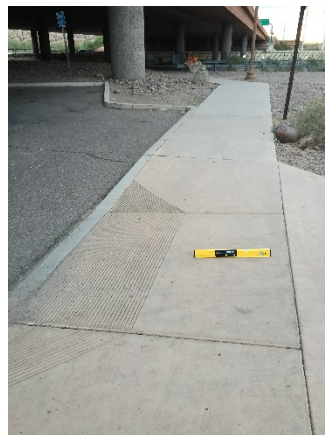
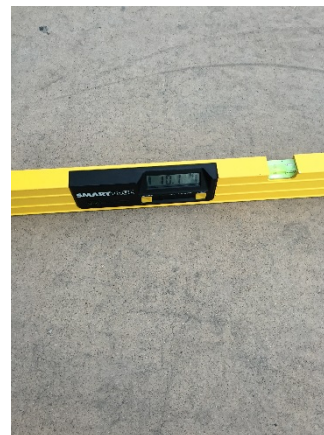
Figures 25 and 26: Curb ramp slope 10.9%

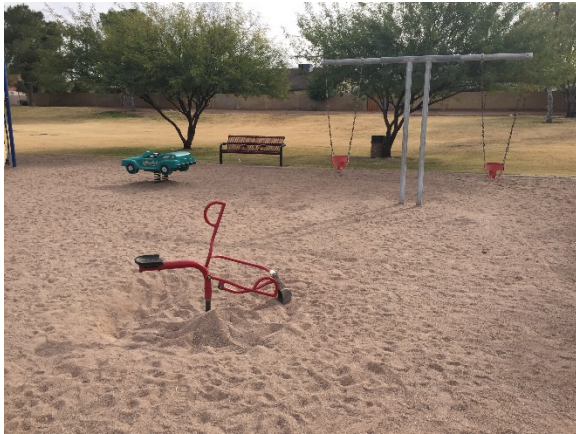
Nine city parks were evaluated (Benedict, Corbell, Dwight, Ehrhardt, Papago, Selleh, Scudder, Svob and Tempe Sports Complex). General issues included no accessible on-street parking, no accessible picnic tables/grilles; no accessible routes to the park amenities (playgrounds, picnic areas, basketball courts, ball fields, soccer fields, etc.). Only one playground, Papago Park, included accessible playground elements although the playground was not in full compliance. The remaining eight (8) parks included playground equipment and playground surfaces that are not in compliance.

*Figure 27: Corbell – Ex: Playground equipment and surfaces not accessible*

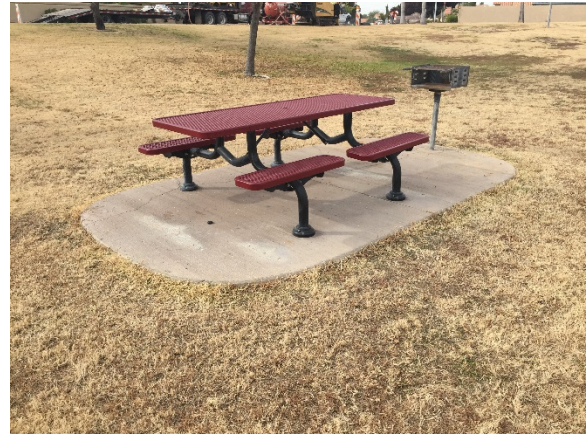
*Figure 28: Corbell – Ex: No accessible route to amenities*

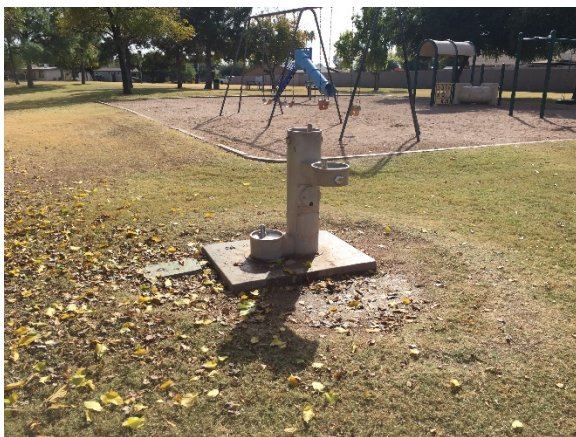
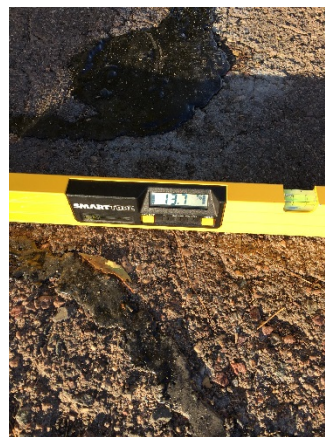
*Figures 29 and 30: Dwight – Ex: No accessible route to amenities*

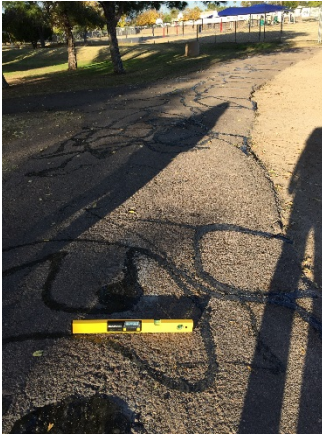
*Figure 31: Selleh – Ex: Existing non-compliant routes*
