**CITY OF TEMPE
HISTORIC PRESERVATION COMMISSION**

**Meeting Date: 09/14/2022
Agenda Item: 6**

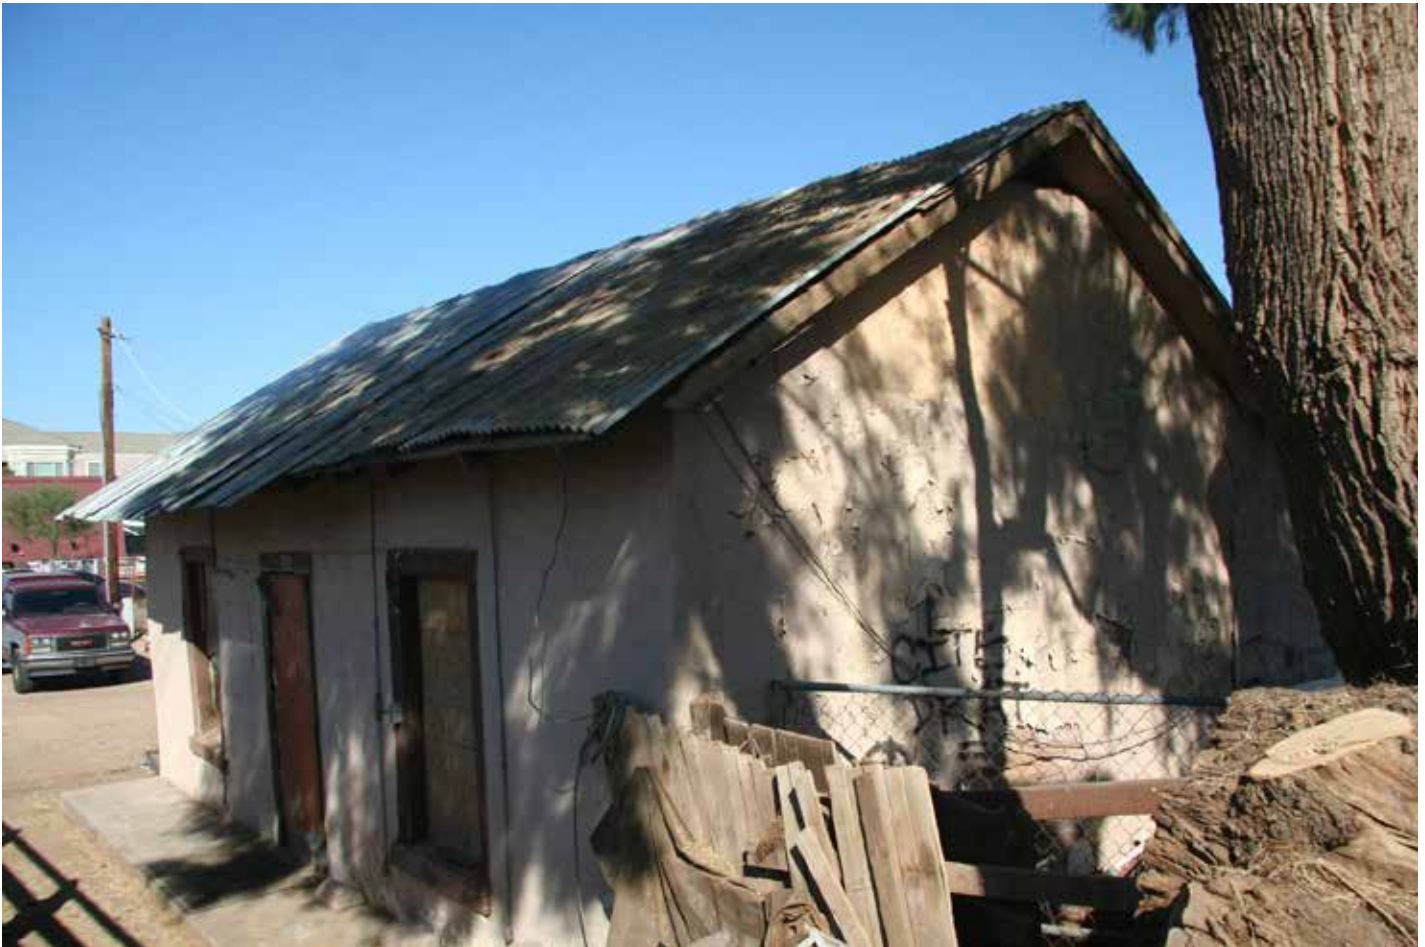
Executive Summary	1
Introduction/Methodology	2
Historical Overview	4
Aerial Photographs	6
Building Description	8
Building Feature Analysis	13
Foundations	14
Vertical Load Systems (Walls/Columns)	16
Floor Systems	18
Roof Systems	20
Lateral Systems (Wind/Seismic)	22
Exterior Skin	24
Exterior Doors	26
Exterior Windows	28
Exterior Floors	30
Exterior Ceilings/Soffits	32
Roof and Drainage	34
Ventilators	36
Chimneys/Flues	37
Miscellaneous Exterior Features	38
Partitions	40
Interior Doors	42
Flooring	44
Ceilings	46
Finish Carpentry	48
Mechanical Systems	49
Plumbing Systems	50
Electrical Systems	52
Grading and Drainage	54
Outbuildings	56
Rehabilitation Recommendations	58
Appendix A: The Secretary of the Interior’s Standards for Rehabilitation	67
Appendix B: Structural Engineering Assessment	68

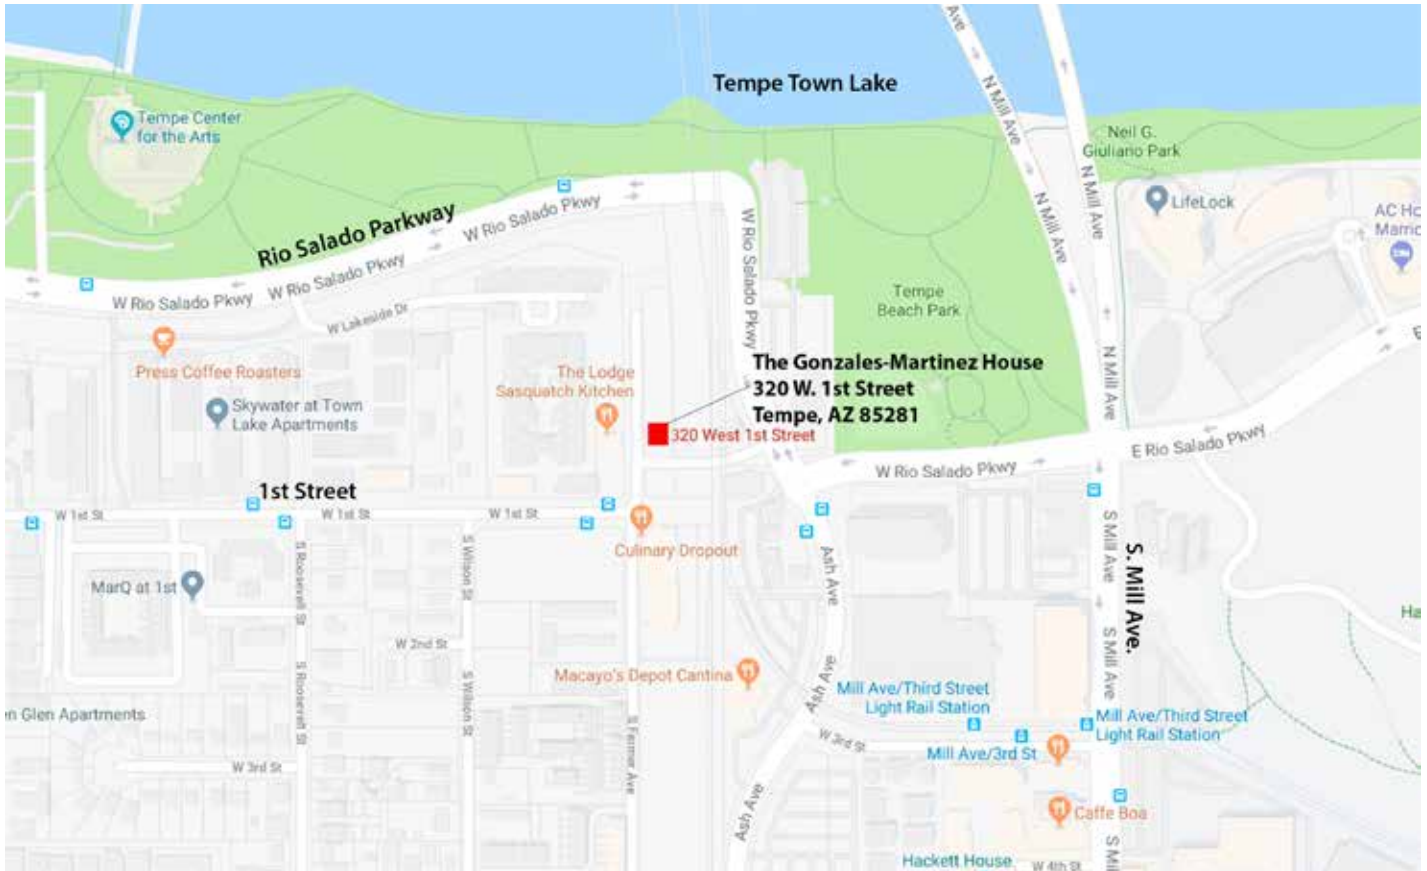
The significance of each feature is noted as

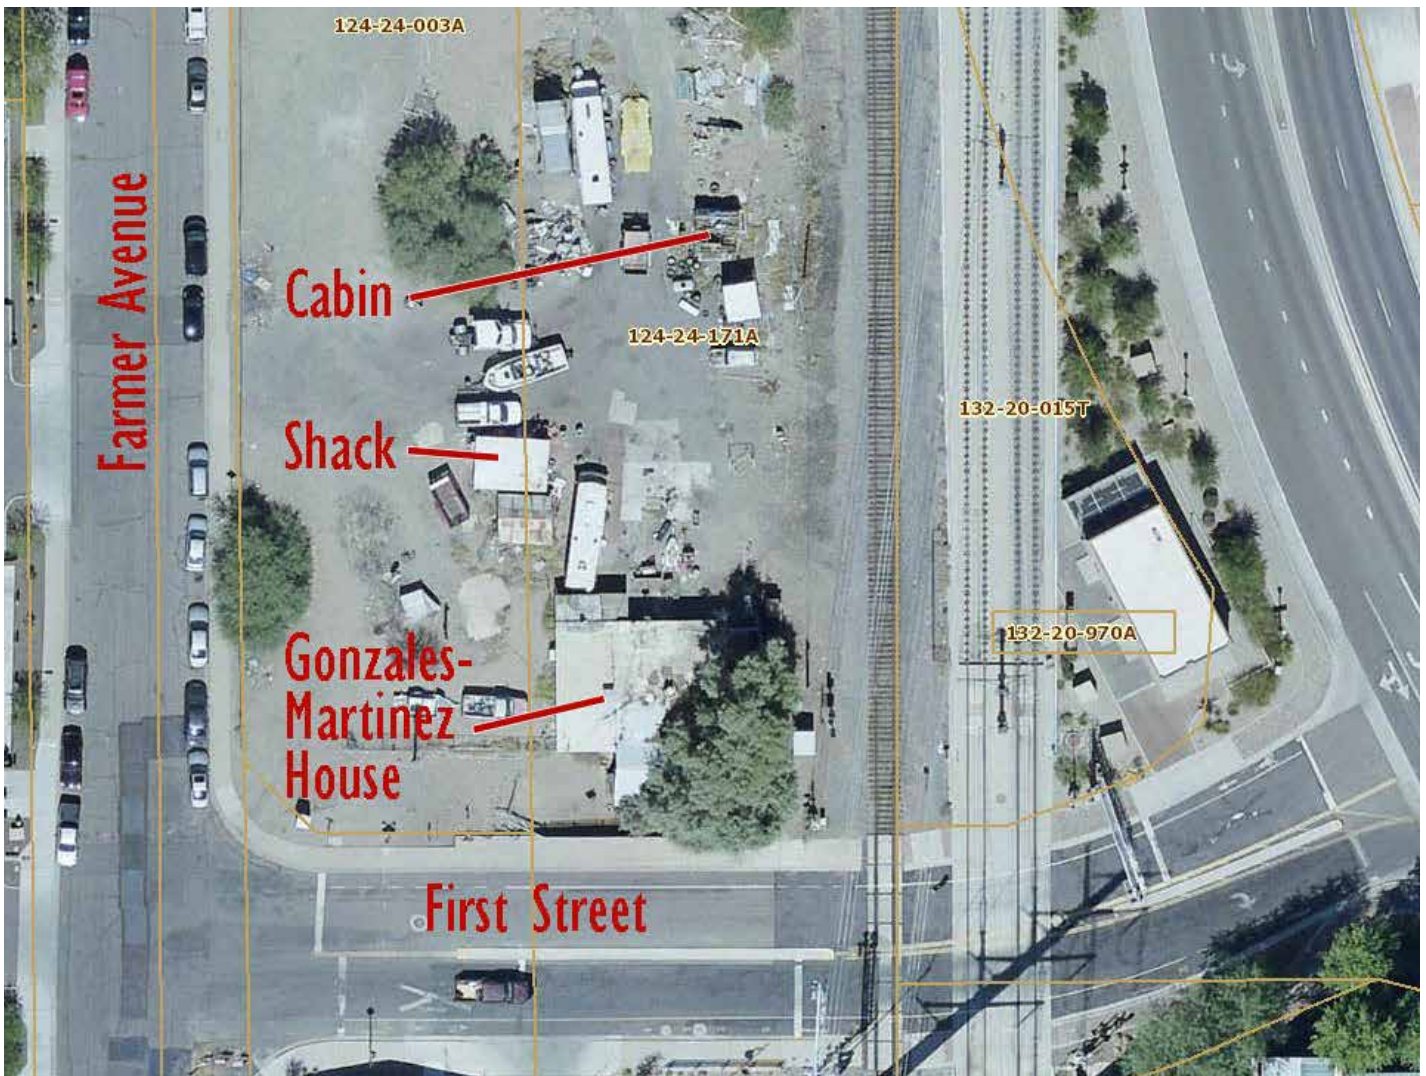
Site Aerial Photo 2017

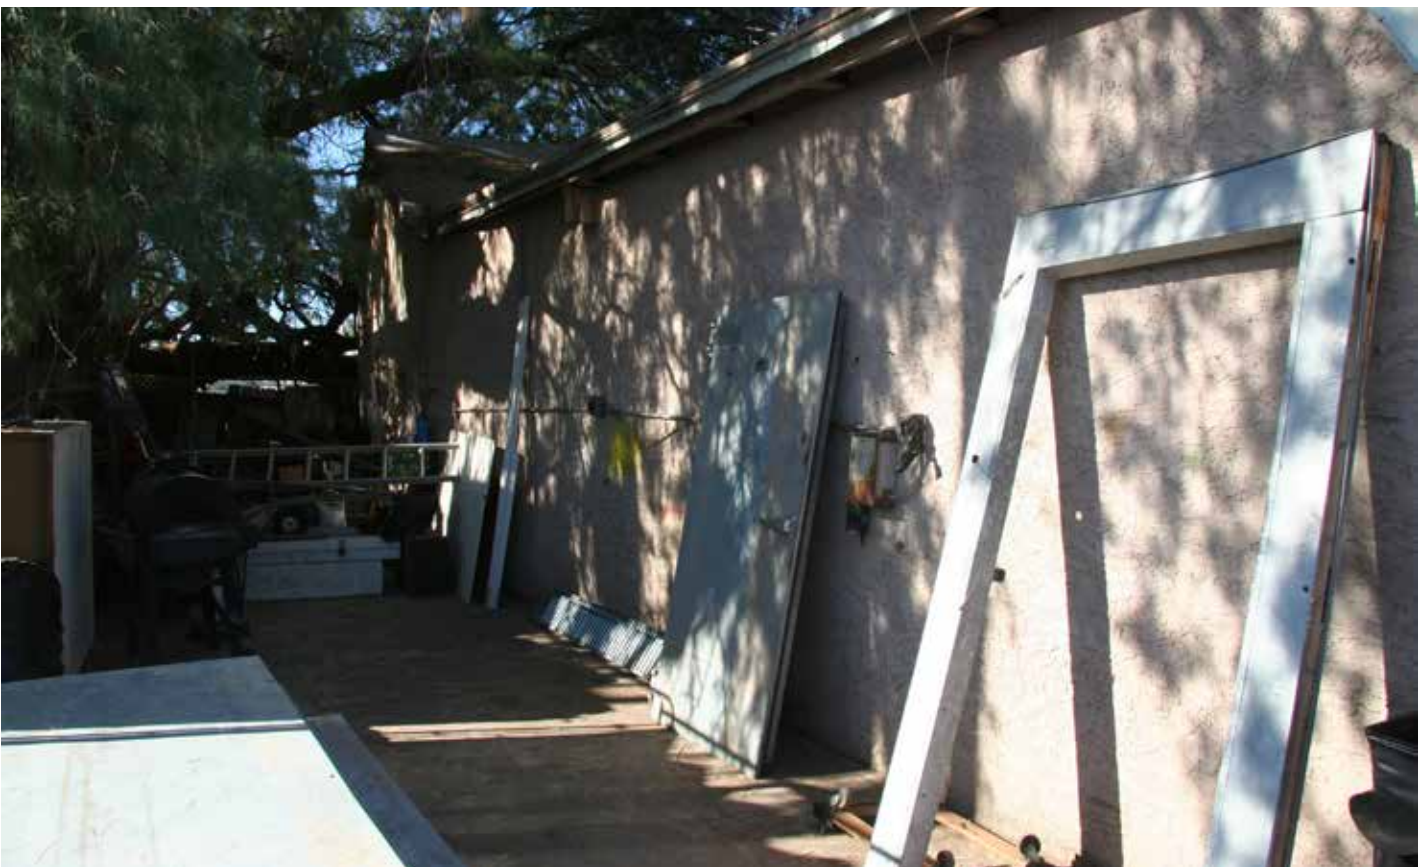
East side of house, looking southwest

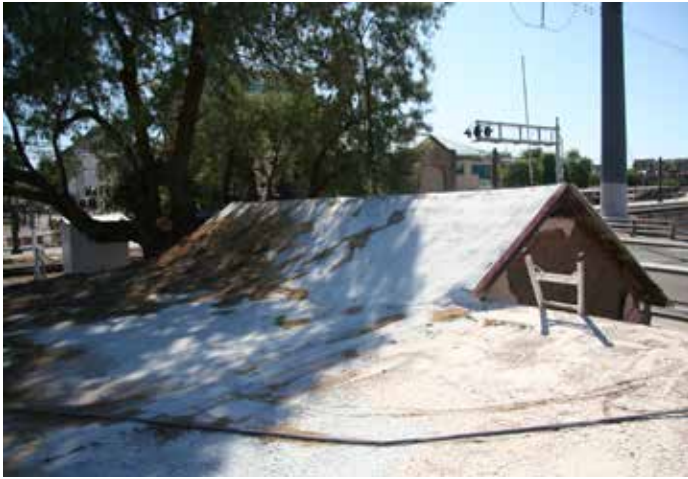
Expose and re-evaluate the portions of roof structure that were not accessible. Repair or reinforce any broken or deteriorated structural members, including the sheathing.

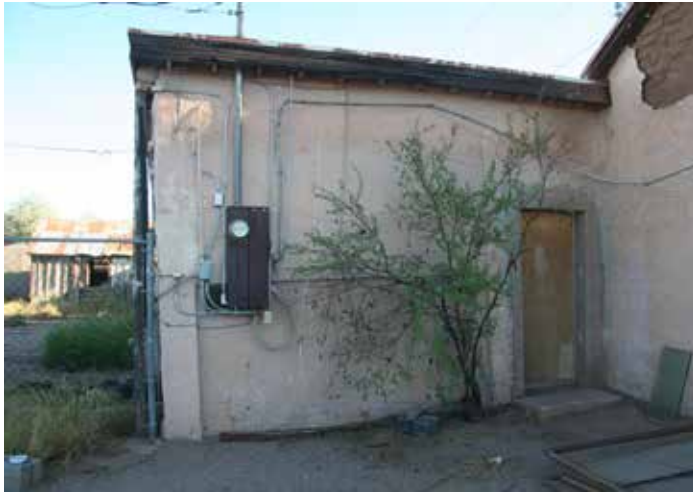
All portland cement stucco should be removed to expose underlying construction for additional evaluation and repair. Most likely, lime plaster remnants will also need to be removed. Repair eroded or damaged adobe brick and re-coat with lime plaster finished in whitewash. After determining the original finish of railroad tie walls, repair and restore to the original appearance.

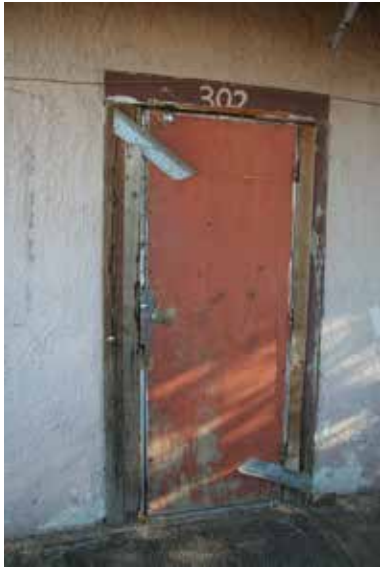
D5, D6, and D7: Remove furring and modern construction elements if the 1980s addition is removed. Provide new wood frame, casings, door leaf and hardware based on physical evidence revealed following removal of concealing finishes.

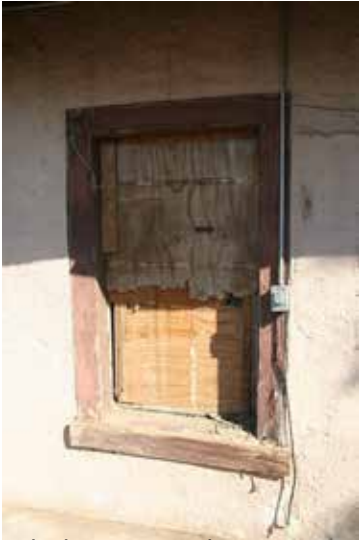
W3 is a modern window with no historical significance. It may be replaced with a more appropriate wood window.

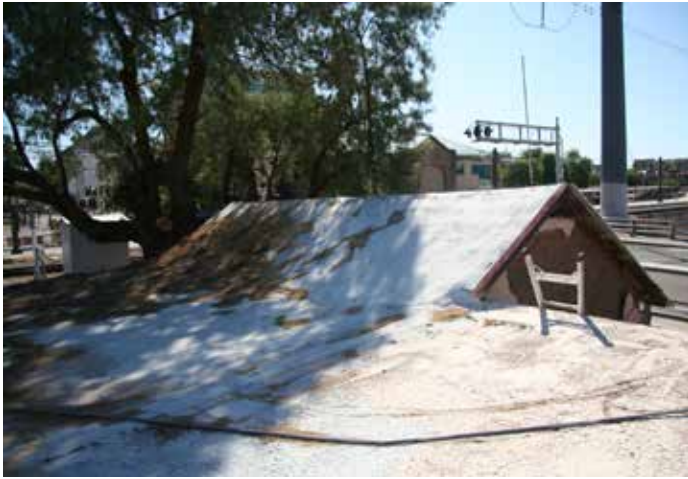
While the 1980s additions remain, it is probably best to maintain the existing roofs. The foam roofing will require patching and re-coating very soon. The ridge also requires a cap flashing to be installed to prevent rain from running in beneath the metal panels.

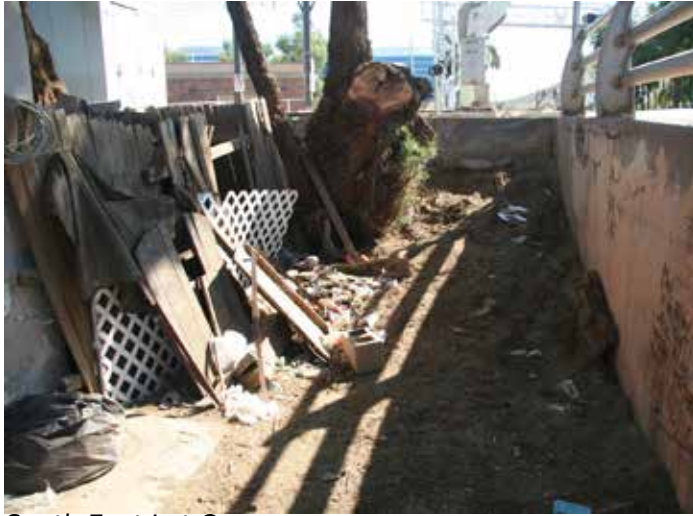
South East Lot Corner
