**CITY OF TEMPE  
HISTORIC PRESERVATION COMMISSION**

**ACTION:** Request for approval of a motion in support of rehabilitating the Historic Eligible and National Register-listed Gonzales-Martinez House, located at 321 West 1st Street.

1. 2017 Building Condition Assessment Report for the Gonzales-Martinez House completed by Motley Design Group, LLC

**A Building Condition  
Assessment of the**

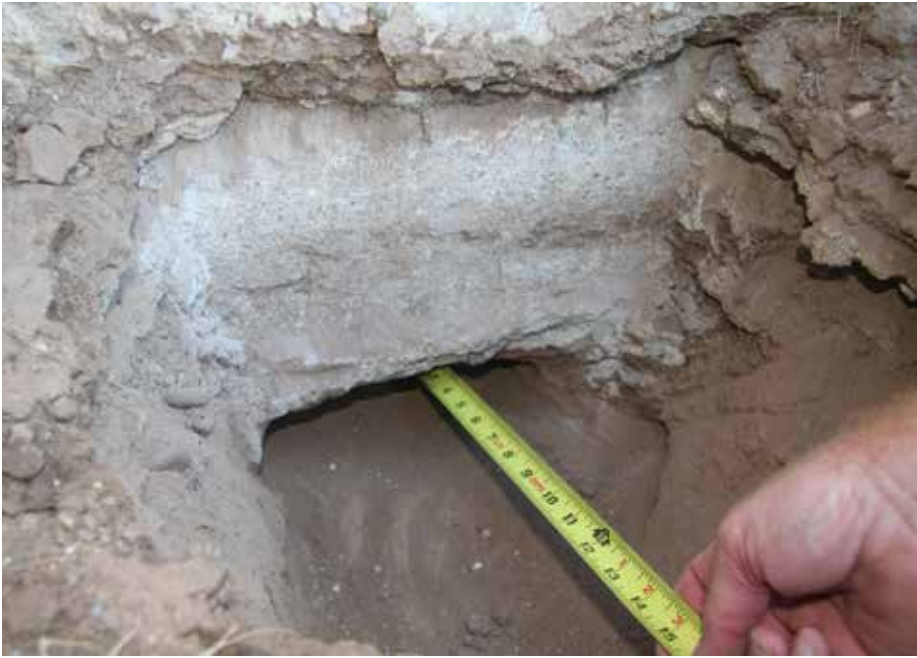
The foundation of the west adobe wall was excavated to a depth of about 12 inches below existing grade. The adobe wall was found to bear directly on earth, although a curb composed of lime mortar or plaster 8 inches high and up to 6 inches wide was found placed within the wall with the top of the curb just below grade.

While the earth at the base of the adobe at grade was found to be damp, it still appeared to be coherent and stable.

*Adobe foundation excavation*

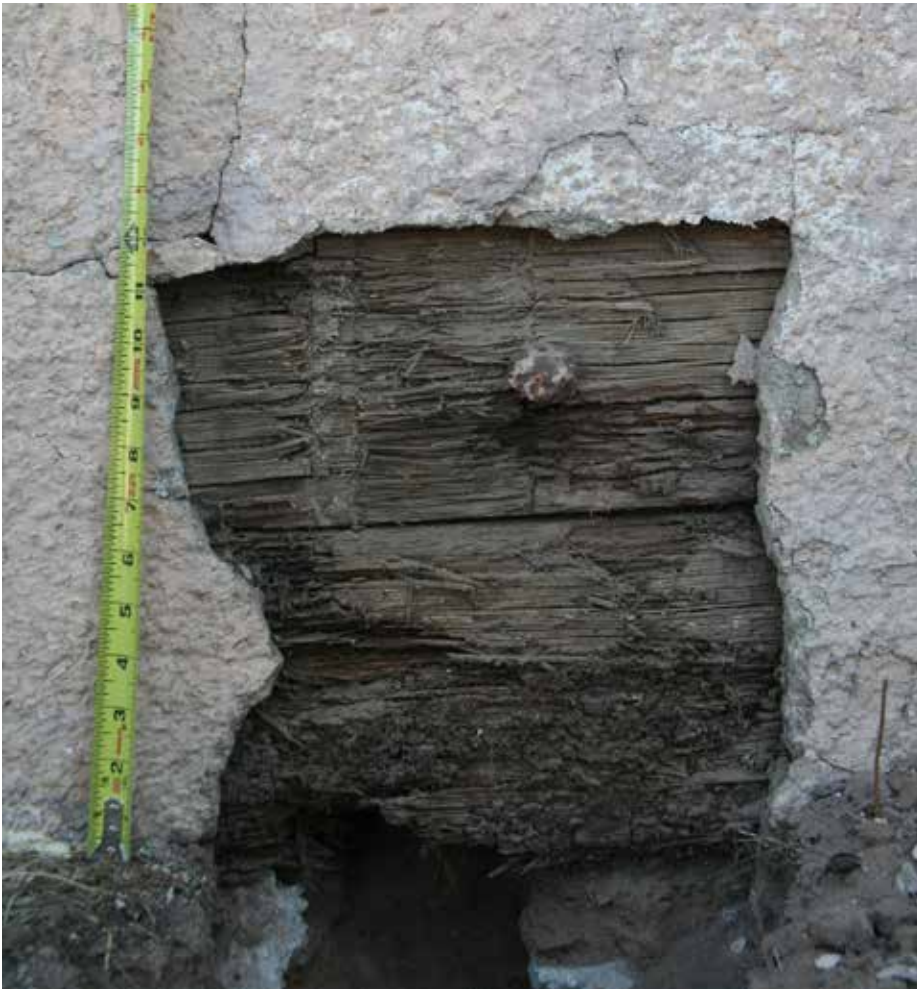
The bottom railroad tie acting as the foundation of the wooden walls was found to be significantly deteriorated by insect damage and rot at the location excavated. The next tie above did not exhibit the same degree of damage. It appears likely that the bottom tie will be found to be similarly deteriorated throughout the structure, although currently concealed by plaster.

*Wood Foundation Test*

Expose and evaluate the bottom wood ties where they are in contact with the earth. Replace all damaged ties using new pressure-treated wood material. Alternatively, if it is found that the original interior and exterior wall finish was plaster, and the wall material will not be exposed, the bottom tie can be replaced with concrete or masonry on a spread footing excavated beneath the wall.

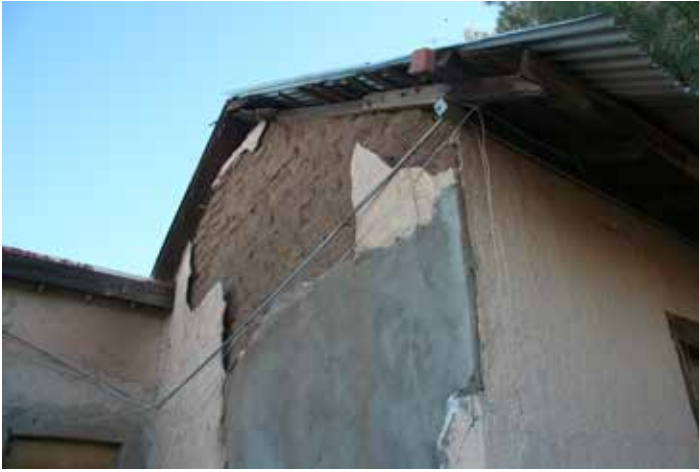
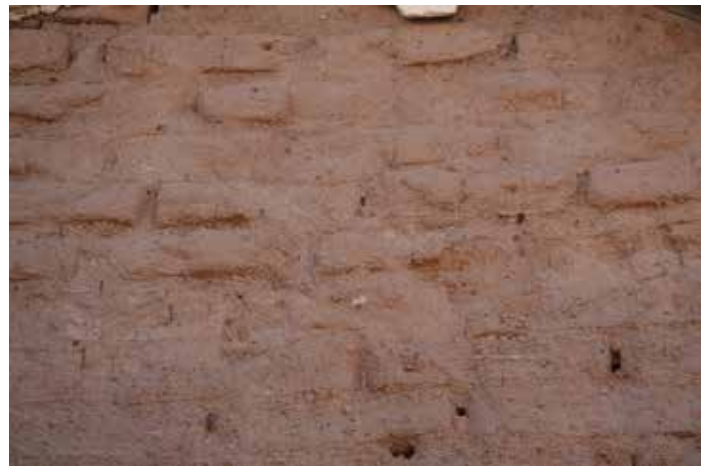
*West Stucco Peel*

An area of the stucco about 10 feet wide and 6 feet high on the exterior of the western adobe wall has broken off, exposing the gable end. The outer stucco coat below this area, which includes a substantial patch reinforced with metal lath, is peeling away from the wall, forming a pocket that traps water and adobe debris sloughing off of the wall above. This condition is progressively worsening as a result.

Remove wall finishes over the adobe (interior and exterior) in order to allow further evaluation. Determine remaining wall thickness at the top of the west wall, and reconstruct if more than 1/3 of the original material has been lost. Minor thickness losses can be built back up with mud plaster keyed into joints in the wall. Where repairs are needed, use mud plaster and/or adobe bricks matching the original construction and composition.

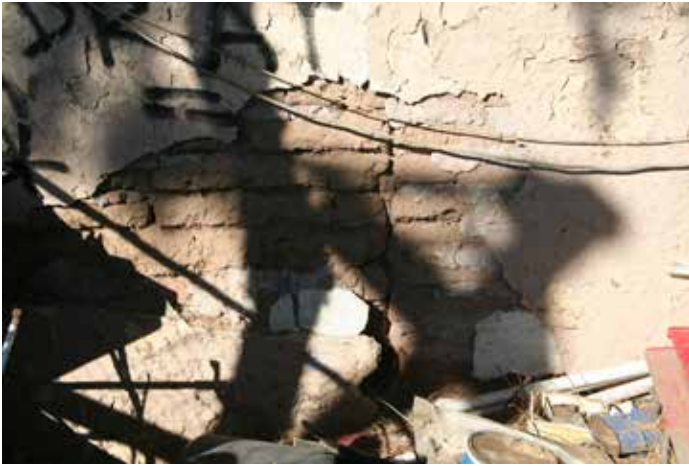
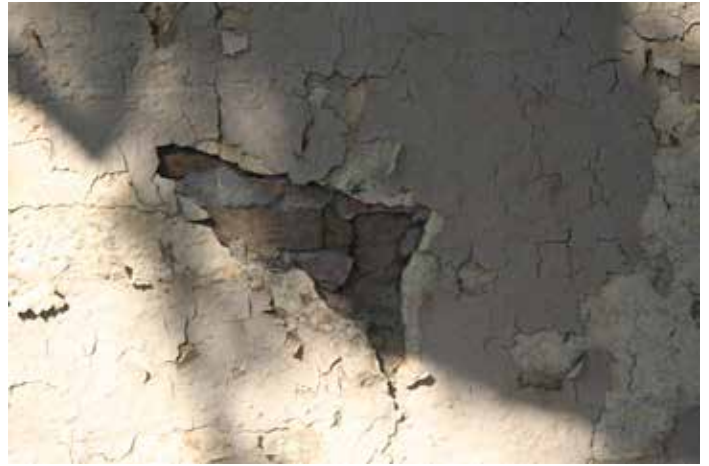
*East Wall Damage*

A second area of wall finish is missing at the east adobe wall. The damage is low on the wall and about 4 feet by 4 feet in area. The adobe joints are deeply eroded where they are exposed.

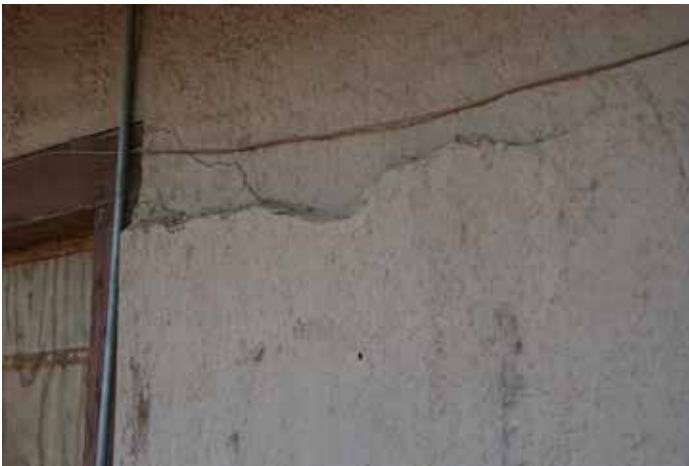
*South Wall Buckling*

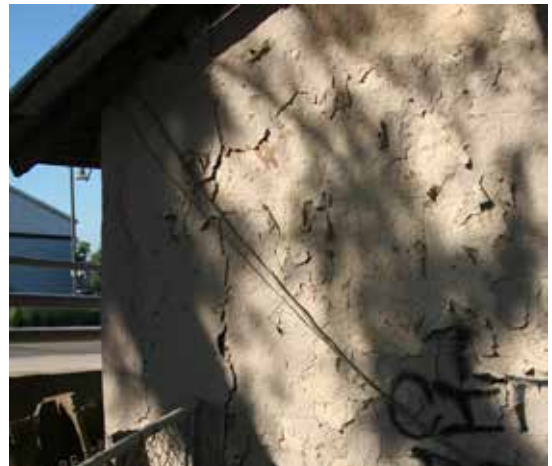
*East Wall Crack*

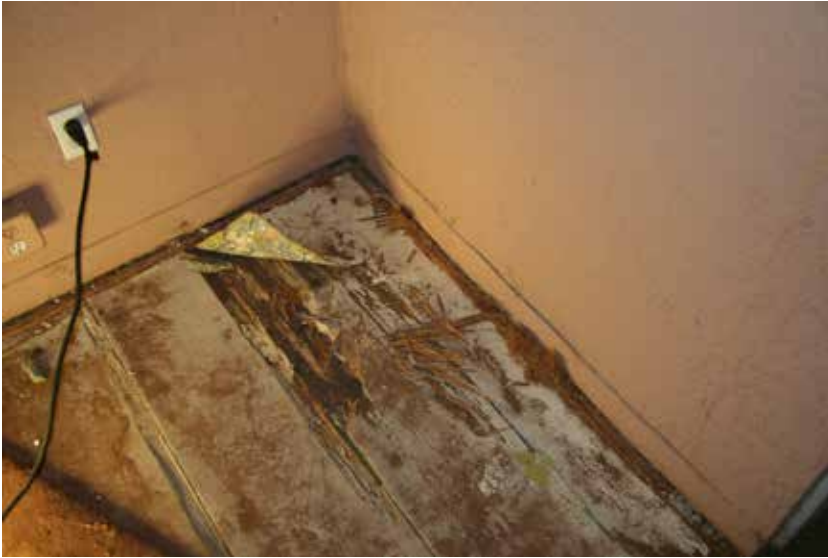
Floor decking in the wood floor areas was partly obscured by stored materials and sheet vinyl. Exposed areas appear sound except for damage in the southwest corner of the room, which has been patched with sheet metal. Removal of some of the decking in this area revealed that the earth in this location has risen through the years, through insect action and fallout through the floor boards, to be in contact with the back of the decking and completely encasing the joists. Probing through the decking at the northern extreme of the room did not encounter soil close to the surface.

*Floor Damage*

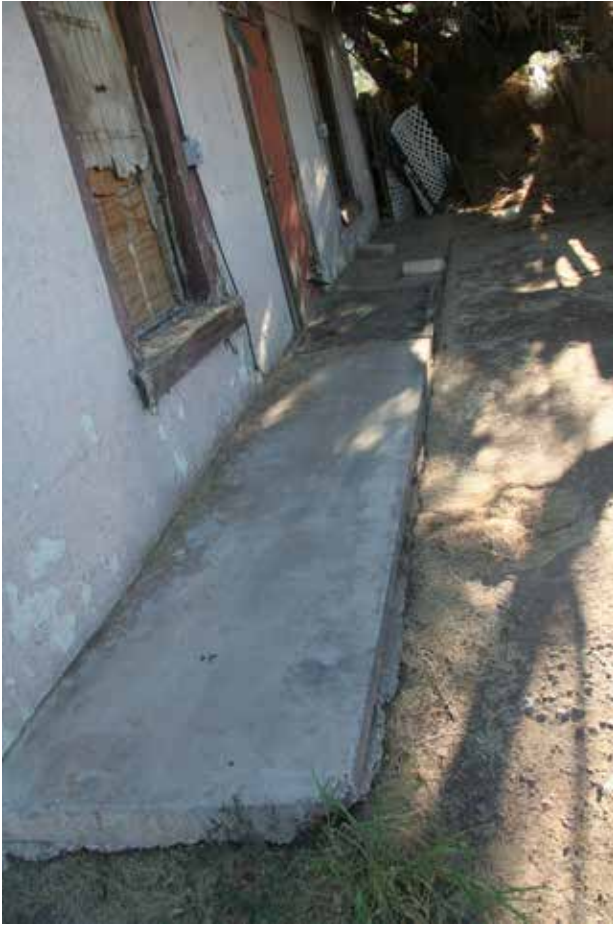
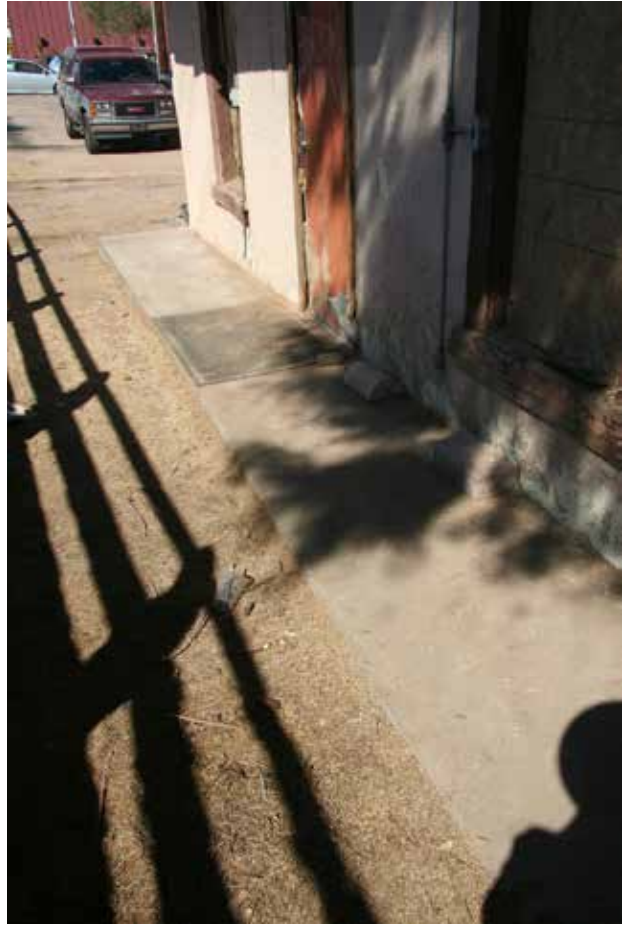
*South Slab*

The exterior walls should be evaluated in the area of this floor following plaster removal, in order to gauge whether the floor may be causing wall damage due to rising damp. If so, the slab should be removed and an alternative, pervious paving or wood porch surface should be provided in its place.

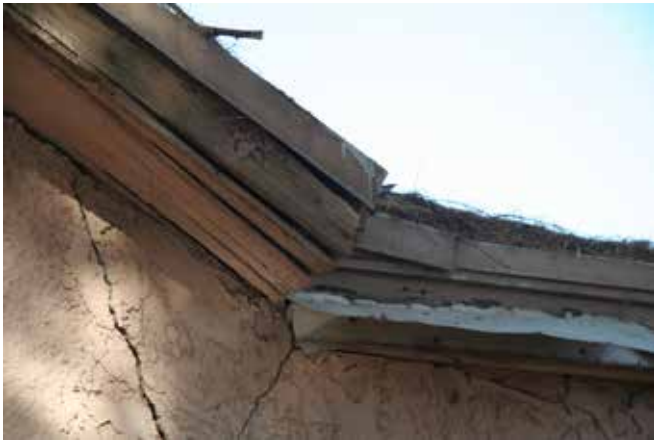
*East Fascia at Joint*

Rotted sheathing boards should be replaced. Weathered rafter tails may be repaired using epoxy consolidants and fillers, then painted. The weathered 2x10 fascias will require replacement.

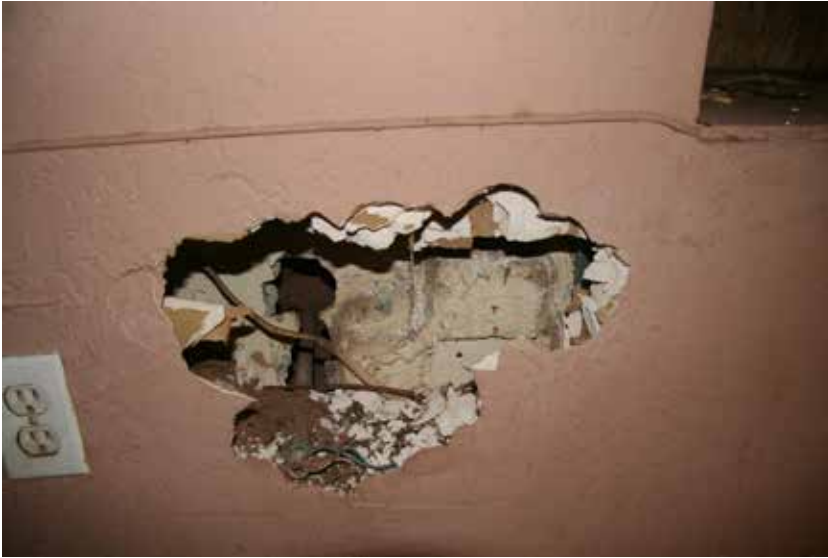
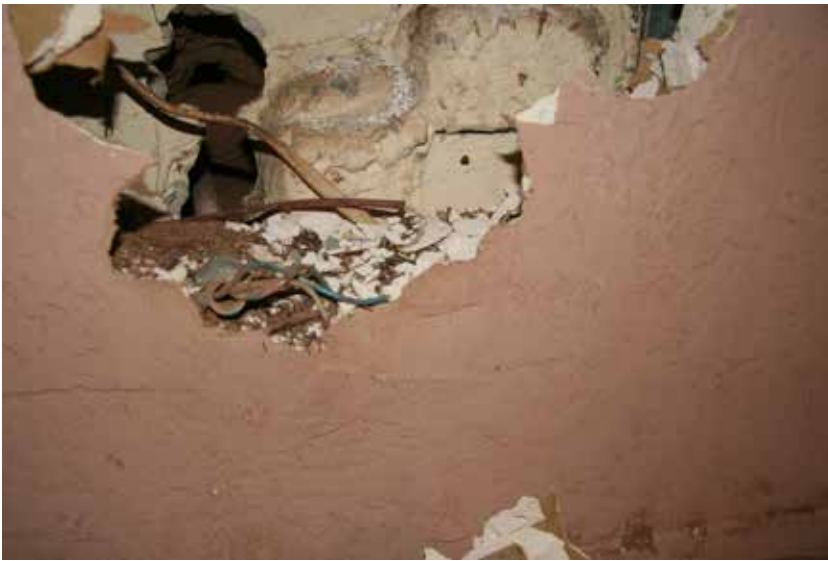
*Adobe Wall base at South*

Remove all interior furring and gypsum board, taking care not to cause additional damage to underlying wall surfaces and door/window trim. Re-evaluate interior face of exterior walls following removal and treat accordingly.

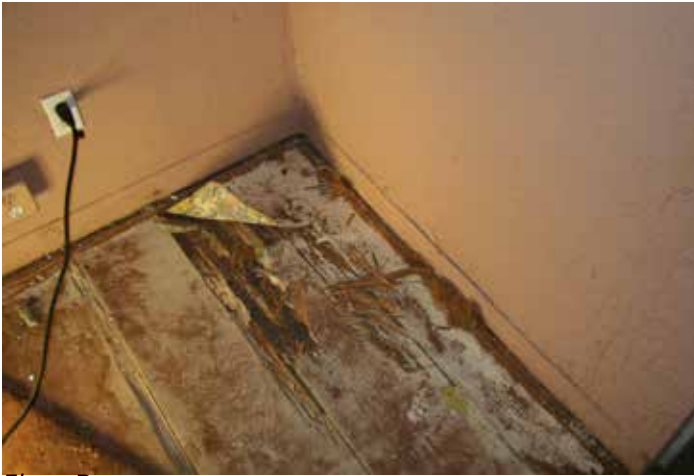
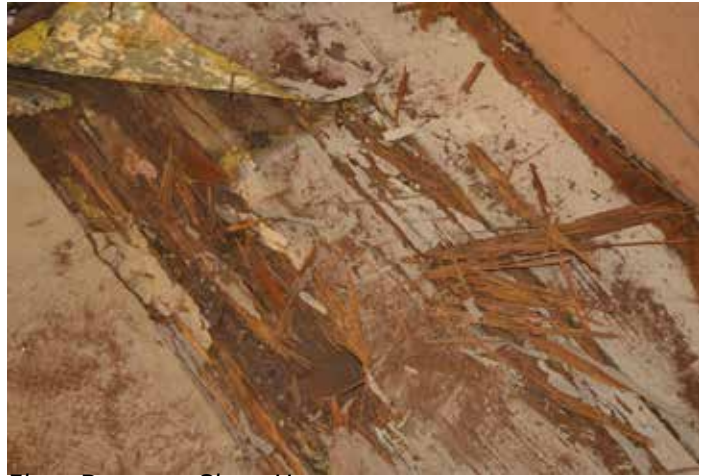
*Floor Damage*

*Floor Damage Close Up*

See also Section A-03. Carefully remove wood board flooring and salvage for re-use to the extent feasible. Following repair of the structure below, reinstall flooring in a manner similar to the original, with spaces chinked with non-synthetic rope and then painted. Supplement missing or damage material with new wood milled to match the size and species of the original floor boards.

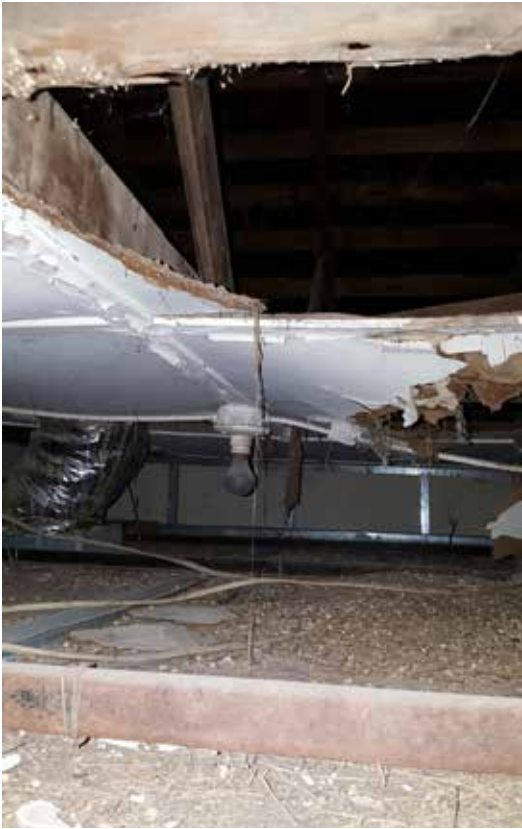
*Old and New Ceilings*

Test "popcorn" ceiling material (as should be done with all suspect ACM) for asbestos content. Remove the material from the surface, using approved techniques. Patch and repair remaining ceiling material in Room 3.

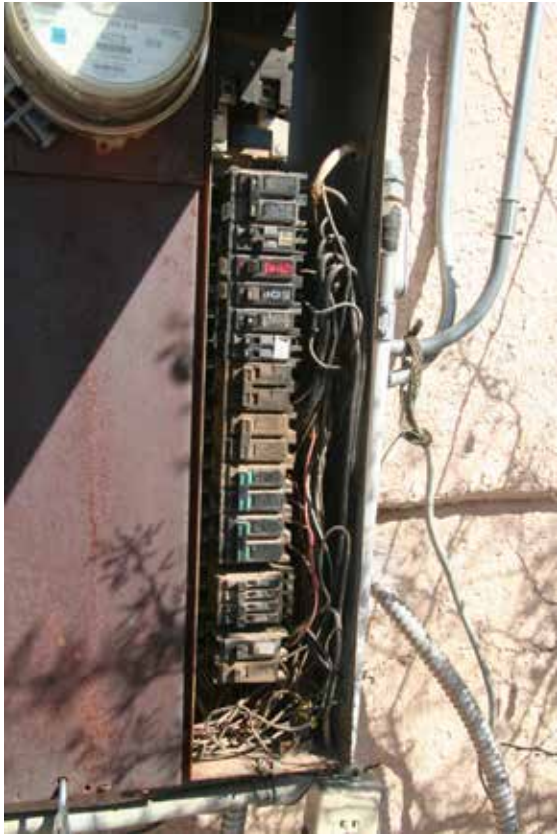
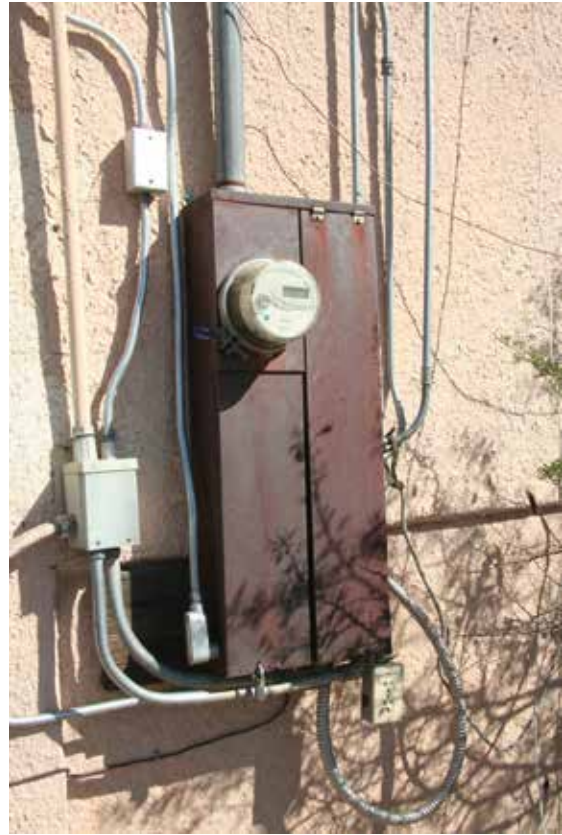
*Circuit Breaker Panel*

*Electrical Service*

Replace the electrical system in its entirety if a rehabilitation is undertaken.

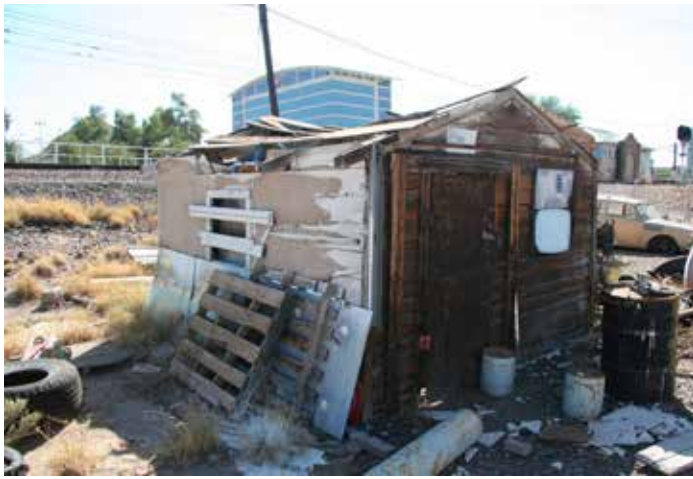
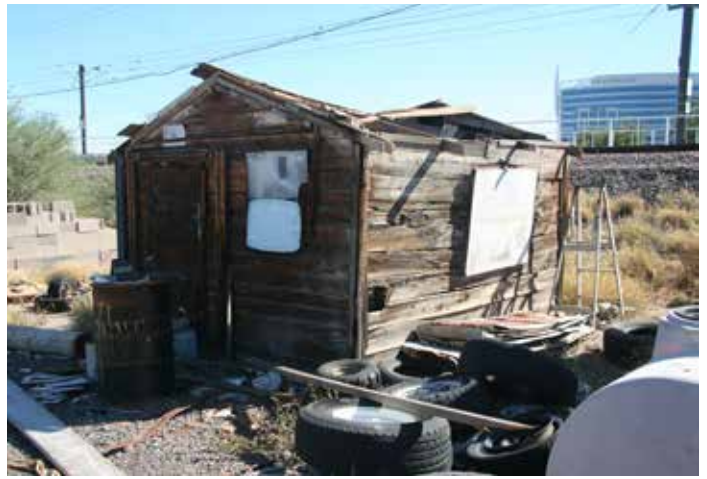
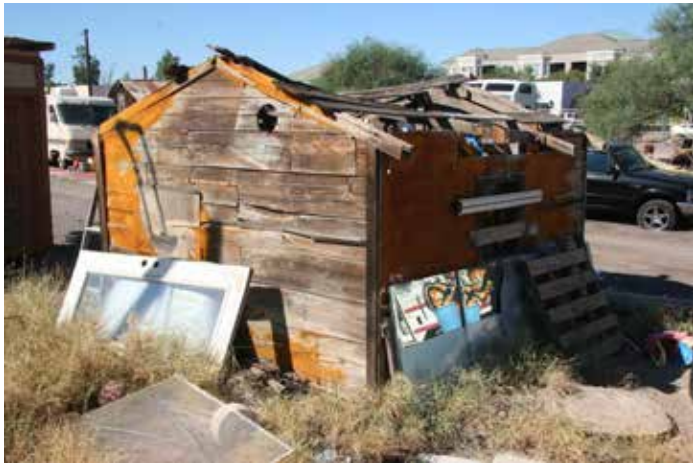
The Cabin appears to be beyond repair and has lost integrity. Additional research specific to the Cabin should be undertaken, and if found significant, it should be documented prior to removal or demolition.

*Cabin Overview to South East*

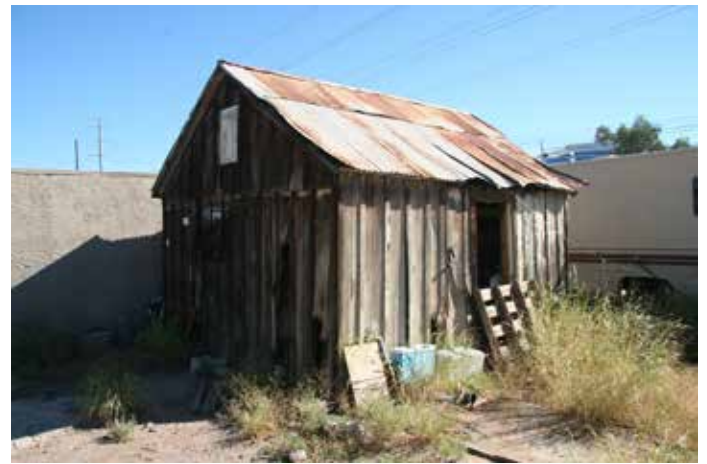
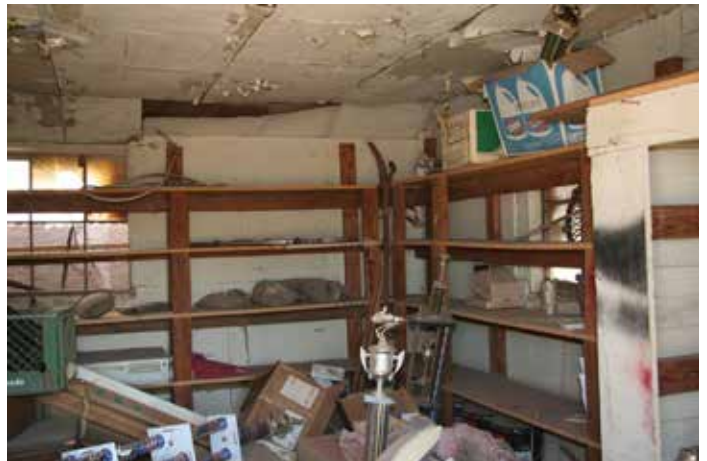
*Shack Overview to North East*

*Shack Interior*

It may be feasible to stabilize the Shack as an interpretive feature of the site. Given its condition, it would be difficult to restore to occupied space. If a place can be found in future site plans, it should be preserved. Since the building was previously moved, its precise location is less important than its general proximity to the main house.
