Kiwanis Park Management Plan Inventory and Assessment

NOVEMBER 2019

Kiwanis Park: Inventory and Assessment

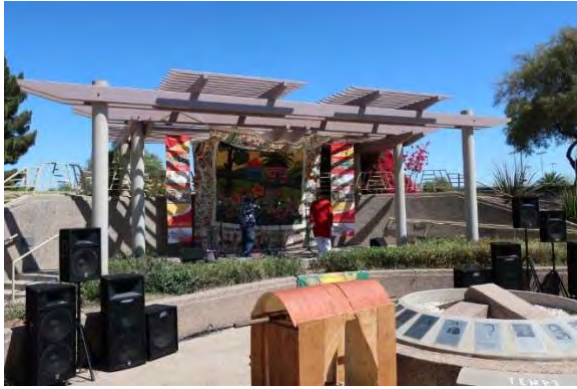
Area 1 (Dick and Jane Neuheisel Sister Cities Garden)

- **Quantity:** 1
- **Location:** West of All America Way and south of the Ruben Romero Area
- **Installation/Renovation:** Unknown
- **Approximate Size:** 2.5 acres (accommodates up to 250 users)
- **Condition Rating:** 1 (significantly below average)
- **Comments:** This area commemorates the Tempe Sister Cities international exchange program and is intended to honor its members, volunteers, program participants, and supporters. However, many plaques are missing, granite bases broken or missing, and

concrete walls have spalling concrete due to structural steel rusting. The plaques, boulders, and planters are spread across the basin area in an unorganized manner that deters the area from being used to its fullest potential for year-round use. The secluded setting offers privacy, but also complicates its location from being known, visited, or surveilled. The Garden is available for recreational use or by reservation.

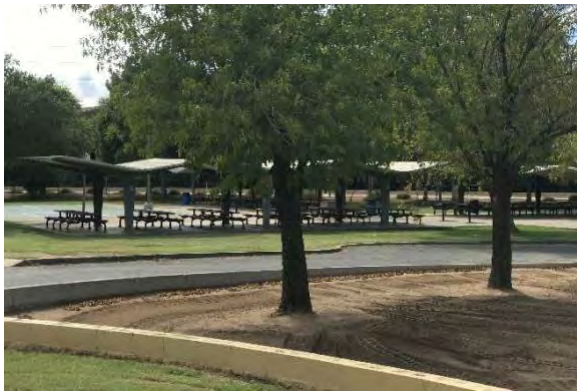
Area 2 (Ruben Romero Picnic Area)

- **Quantity:** 1
- **Location:** Southwest of the lake
- **Installation/Renovation:** Unknown
- **Approximate Size:** 4.5 acres (accommodates up to 1,000 users)
- **Condition Rating:** 3 (average)
- **Comments:** This area is enclosed by fencing, secured by locked gates, and is available only by reservation. It can be divided into two sub-areas (north and south) with roughly equivalent supporting assets. Each sub-area contains large group ramadas, picnic tables, grills, and trash receptacles. Additional assets

include volleyball courts, horseshoes, a playground, and restrooms. The secluded setting offers privacy for events, but also complicates its location from being known, visited, or surveilled. Except on weekends when it has a reserved use, the area is below average in utilization.

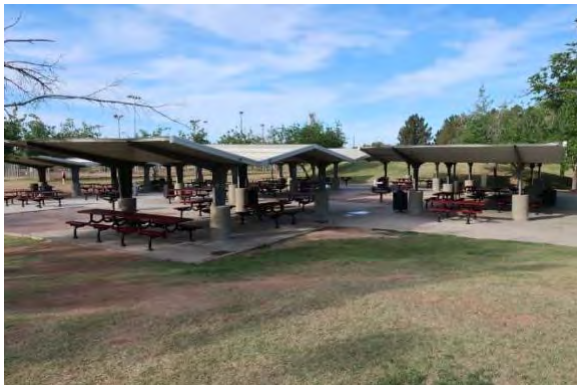
Area 3 (Fiesta Group Ramadas)

- **Quantity:** 6 ramadas (a seventh ramada was removed due to storm damage; the associated picnic tables remain in place uncovered)
- **Location:** East of All America Way and north of Volleyball Courts 3–5
- **Installation/Renovation:** Minor renovation in 2013
- **Approximate Size:** 13,500 square feet (three ramadas are roughly 65' x 24' and three are roughly 44' x 24'); this area accommodates up to 250 users)
- **Condition Rating:** 3 (average)
- **Comments:** Each ramada pod is available for

recreational use or by reservation. The entire area is also available for reservation. Support assets include

picnic tables, grills, and trash receptacles. Adjacent primary assets include three volleyball courts, a playground, and a basketball court.

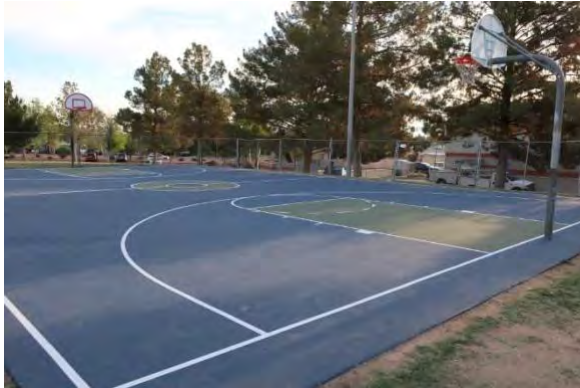
Basketball 1–3

- **Quantity:** 3
- **Location:** Ruben Romero (2) and Fiesta (1)
- **Installation/Renovation:** Resurfaced in 2015 (Ruben Romero) and 2019 (Fiesta)
- **Approximate Size:** 4,000 square feet
- **Condition Rating:** 4 (above average)
- **Comments:** The solar orientation of the courts is generally north-south, which is ideal. The Ruben Romero courts are only available when the area is open.

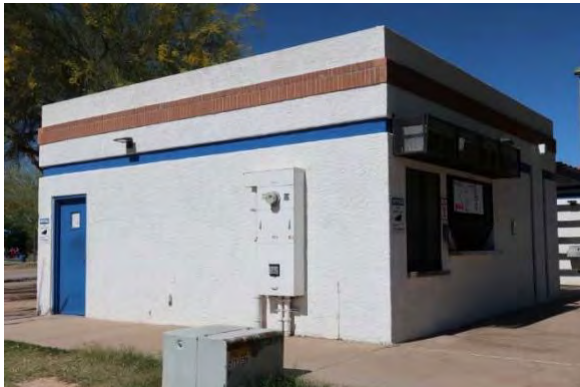
Concessions

- **Quantity:** 1
- **Location:** North of lake
- **Installation/Renovation:** Unknown
- **Approximate Size:** 24' x 24' (576 square feet)
- **Condition Rating:** 2 (below average)
- **Comments:** This masonry structure that appears to be original to the park. It includes two main rooms – the concessions window area and a kitchen area. The kitchen area is not used to its highest potential as it doesn't meet Maricopa County Department of Environmental Services codes. Food concessions are limited to pre-packaged goods. Storage is limited. The

concessionaire uses two 8' x 25' mobile containers for additional storage.

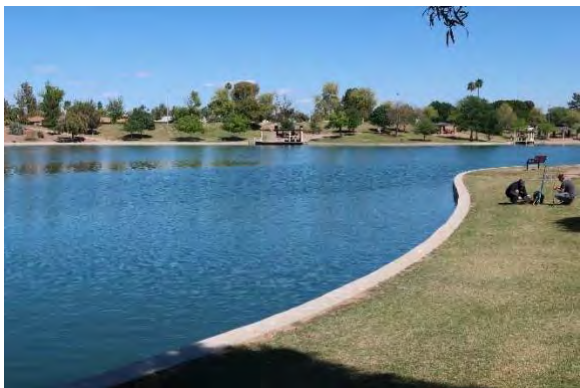
Lake

- **Quantity:** 1
- **Location:** West of Mill Avenue and north of All America Way
- **Installation/Renovation:** The lake edge was renovated and the lake aeration system was added in 2018. The lake edge shelf was cleaned approximately ten years ago at which time a new irrigation pump station and fish habitats were also installed.
- **Approximate Size:** 12.7 acres
- **Condition Rating:** 3 (average)
- **Comments:** The lake is the visual focal point of the park and is prominently visible from most of the

north park areas and is intermittently visible from along Mill Avenue and All America Way. The lake is encircled by a 0.72-mile sidewalk path that is frequently used by passive exercise walkers. The open space surrounding the lake is used for fishing, photography, etc. It is included in the Arizona Game and Fish Department's Community Fishing Program and, depending on season, is stocked with catfish, trout, sunfish, and bass. Support assets include two boat docks and seven fishing ramadas, all of which are scheduled for replacement or renovation for their continued use. The park concessionaire provides boat rentals as well. The lake is used for irrigation storage for the park and serves as a stormwater basin for the

surrounding residential community, which affects its water quality. The lake's water source is from the adjacent Western Canal and from stormwater.

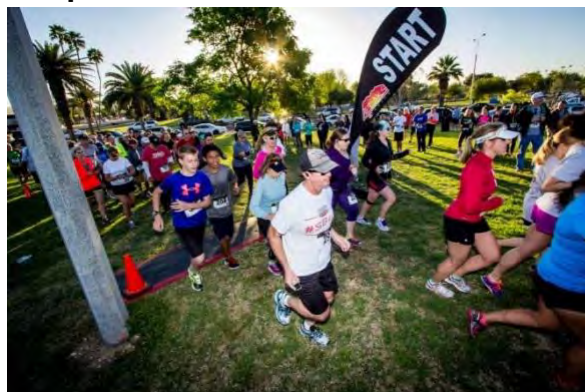
Loop Trail / 5k Route

- **Quantity:** 3
- **Location:** Throughout park
- **Installation/Renovation:** N/A
- **Approximate Size:** Length varies
- **Condition Rating:** 3 (average)
- **Comments:** The route that is used most often is known as the Doug Conley Memorial Route. None of the routes appear to be signed, but rather are likely signed as events are staged.

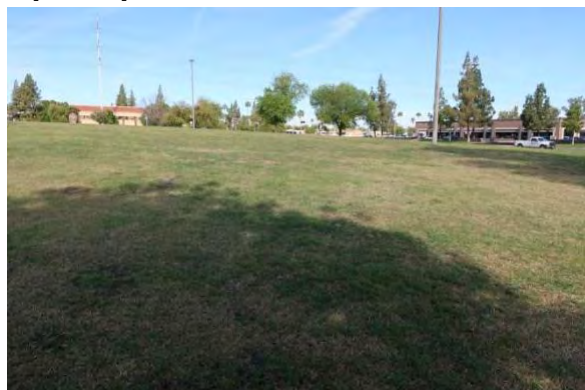
Open Space Area

- **Quantity:** 4
- **Location:** South of Baseline Road, east of the lake, northeast of the Fiesta Group Ramadas, and east of the batting range
- **Installation/Renovation:** Unknown
- **Approximate Size:** 2.5 to 4.5 acres
- **Condition Rating:** 3 (average)
- **Comments:** Three of these large turf areas have significant elevation variation, creating berms in some areas that form visual barriers into the park. These areas are typically underutilized even as open play areas.

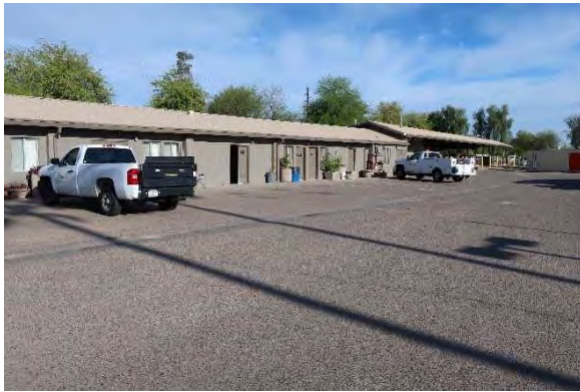
Operations and Maintenance Yard

- **Quantity:** 1
- **Location:** West of All America Way and north of the Robert L. Hawk Police Station and Guadalupe Road
- **Installation/Renovation:** Minor/limited renovation in 2001
- **Approximate Size:** 3.5 acres (including equestrian exercise area)
- **Condition Rating:** 2 (below average)
- **Comments:** Though not a primary recreational asset, this yard is a primary park feature in terms of space and function. At its southern end, the yard

houses Fleet Services. The building north of this shop has administrative offices for the Parks and Recreation Division. The northern portion of the yard features equestrian stables and staging areas for the Tempe Police Mounted Unit as well as storage areas.

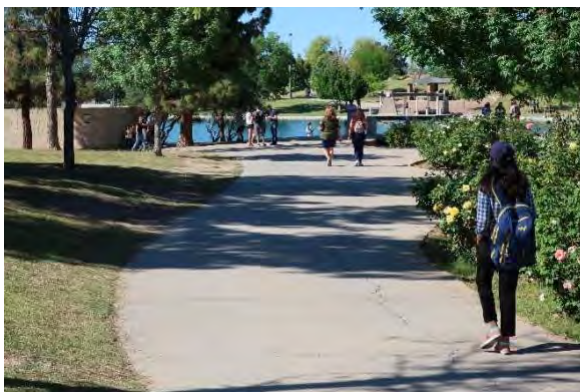
Path Network

- **Quantity:** N/A
- **Location:** Parkwide
- **Installation/Renovation:** Unknown
- **Approximate Size:** 15,900 linear feet of concrete paths and sidewalks (3.01 miles), not including sidewalks attached to streets and parking lots
- **Condition Rating:** 3 (average)
- **Comments:** The on-site path network is extensive and includes walkways of varying widths and topography. Of the approximate length above, the route around the lake is approximately 3,900 linear feet (0.74 miles). Offsite paths that connect to the park

include the Western Canal Multi-use Path along the western park boundary and the El Paso Gasline Multi-use Path north of Aguilar Elementary School.

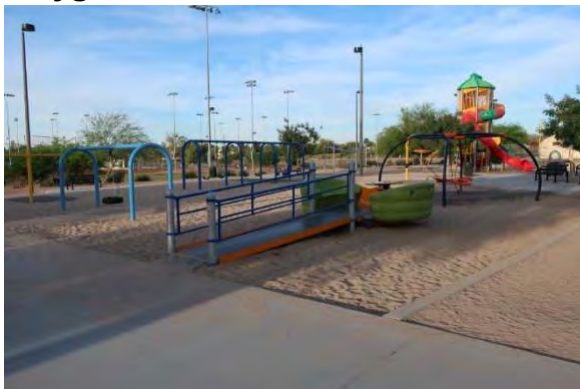
Playground 1

- **Quantity:** 2 (separate areas for ages 2–5 and ages 5–12)
- **Location:** East of Fiesta Group Ramadas
- **Installation/Renovation:** 2015
- **Approximate Size:** 40,000 square feet
- **Condition Rating:** 4 (above average)
- **Comments:** The playground offers a wide array of play opportunities. Play surfaces include rubberized surfacing and sand. The area is lighted and partially shaded. Support assets in the vicinity include benches, picnic tables, drinking fountains, trash receptacles, and restrooms.

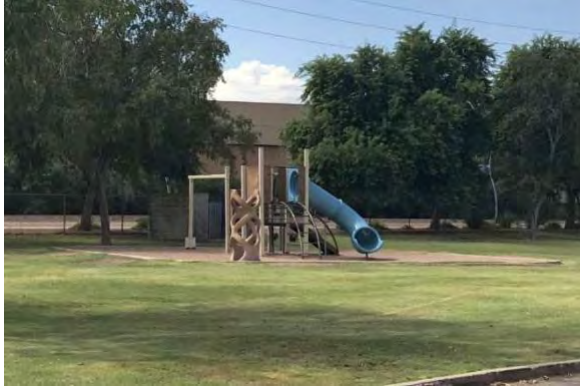
Playground 2

- **Quantity:** 1 (ages 2–5)
- **Location:** Ruben Romero Corporate Area
- **Installation/Renovation:** Unknown
- **Approximate Size:** 1600 square feet
- **Condition Rating:** 1 (significantly below average)
- **Comments:** This small playground offers minimal play opportunities. The play surface is sand. There is no play specific lighting nor is there shade provided. It is not an accessible playground and is likely considered to be grandfathered as being developed prior to the enactment of the Americans with Disabilities Act.

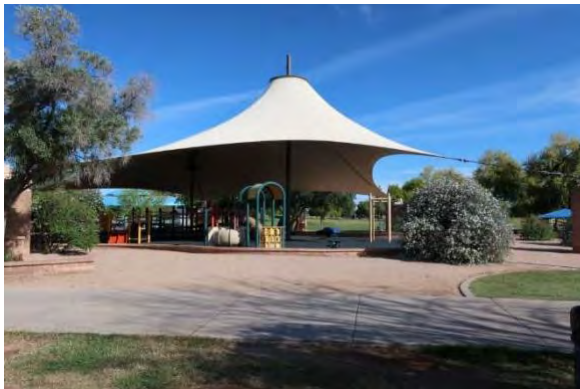
Playground 3

- **Quantity:** 1 (ages 2–5)
- **Location:** North of the lake near “The Cloud”
- **Installation/Renovation:** The last renovation was prior to 2004
- **Approximate Size:** 12,000 square feet
- **Condition Rating:** 2 (below average, but well maintained)
- **Comments:** This playground offers a moderate array of play opportunities. It is lighted and partially shaded by a large fabric structure. Play surfaces include rubberized surfacing and sand. Support assets in the vicinity include benches, drinking fountains,

trash receptacles, ramadas, picnic tables, and restrooms.

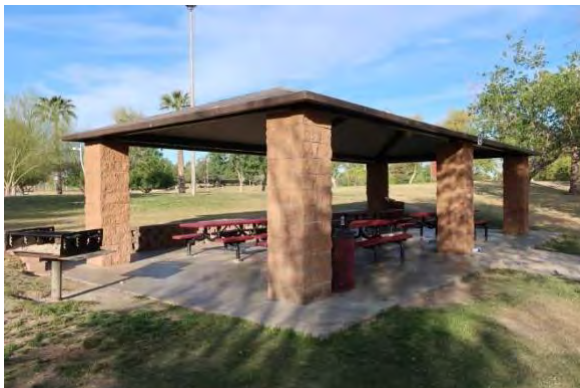
Ramadas 1–15

- **Quantity:** 15
- **Location:** Around the lake
- **Installation/Renovation:** between 2005 and 2008
- **Approximate Size:** 20' x 20' (400 square feet) and 20' x 40' (800 square feet)
- **Condition Rating:** 3 (average)
- **Comments:** The park’s original custom ramadas were replaced with hipped metal roof/masonry column ramadas that are very typical of many current-era Valley area parks. The ramadas include picnic tables, grills, and trash receptacles. All are available for recreational use and by reservation. The seven fishing

ramadas are not included in this category as a primary asset as they are support assets to the lake primary asset and are not reserveable.

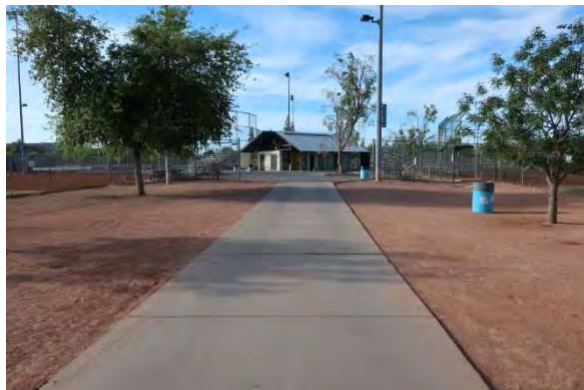
Softball Complex (Fields 1–4)

- **Quantity:** 4
- **Location:** East of All America Way between the Fiesta Group Ramadas and the Batting Range
- **Installation/Renovation:** The infields were renovated to include dustless infield mix in 2017 and 2018. The restroom facility was removed and replaced in 2016. Backstops on three of the four fields were replaced in the early 2010s.
- **Approximate Size:** The varying field sizes limits the quality of league play that can be offered at the park. The infield base distances are 60 feet, 65 feet, and 70 feet. The outfield fence lengths vary greatly,

with the field lengths being:

- Southeast 300'
 - Northeast 275'-290'
 - Northwest 235'-260'
 - Southwest 225'-265'
- **Condition Rating:** 3 (average)
 - **Comments:** League and recreational softball activity is offered at the park with these fenced and lighted fields. Other supporting assets include bleachers and trash receptacles. Other than a few scattered trees and windscreens over the dugouts, there is no shade provided.

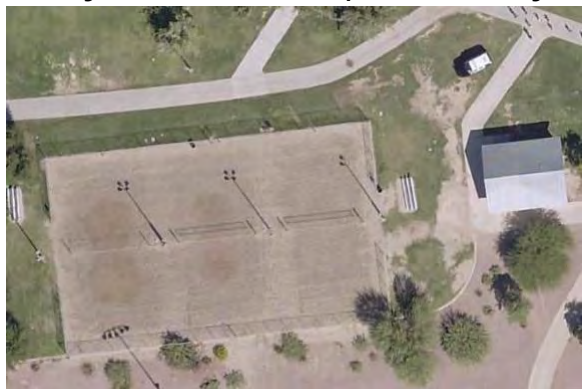
Volleyball Courts 3–5 (Fiesta Volleyball: West, Center, East)

- **Quantity:** 3
- **Location:** South of the Fiesta Group Ramadas
- **Installation/Renovation:** Unknown
- **Approximate Size:** 13,000 square feet (total sand area)
- **Condition Rating:** 3 (average)
- **Comments:** These sand courts are lighted for night-time use, are enclosed with a chain-link fence, and include a court watering system. Support amenities include bleachers and adjacent restrooms. The courts' solar orientation is generally north-south.

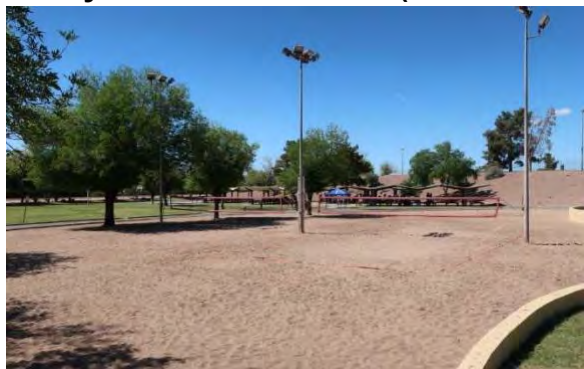
Volleyball Courts 6 and 7 (Ruben Romero Volleyball: West and East)

- **Quantity:** 2
- **Location:** Ruben Romero Picnic Area
- **Installation/Renovation:** Unknown
- **Approximate Size:** 18,100 square feet (total sand area)
- **Condition Rating:** 3 (average)
- **Comments:** These sand courts are lighted for night-time use. Support amenities include adjacent restrooms. The solar orientation of the courts is generally north-south.

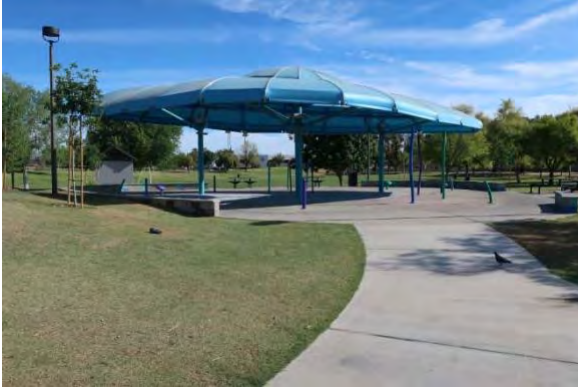
Water Play (The Cloud)

adjacent small 10' x 10' equipment building.

- **Quantity:** 1
- **Location:** south of Baseline Road
- **Installation/Renovation:** Opened in 2018
- **Approximate Size:** 5,000 square feet
- **Condition Rating:** 5 (significantly above average)
- **Comments:** “The Cloud” is Tempe’s largest water play attraction. The amenity has several water features, including a storm sequence replete with thundering sound effects and lighting. The splash playground includes shade over much of the area. Supporting assets include picnic tables, benches, trash receptacles, and adjacent ramadas. Support amenities include an

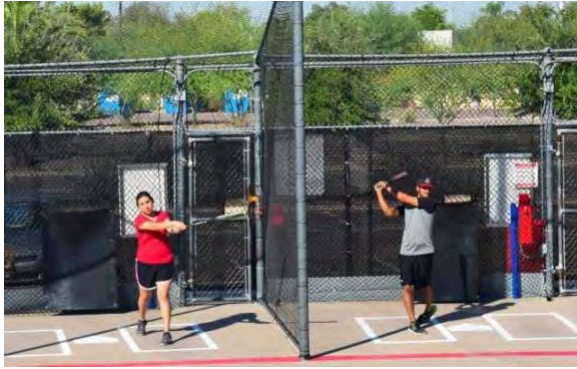
Batting Range

- **Quantity:** 10 cages (baseball, slow-pitch softball, and fast-pitch softball)
- **Location:** North of Kiwanis Recreation Center
- **Installation/Renovation:** August 1990. Renovation in October 1997. Pitching machines replaced in April 2015.
- **Approximate Size:** 19,800 square feet (total fenced enclosures)
- **Condition Rating:** 4 (above average)
- **Comments:** A T-ball area for younger age users who are not ready for batting cages is available. The

City took over operation in August 1990. The batting range is operated by Tempe staff.

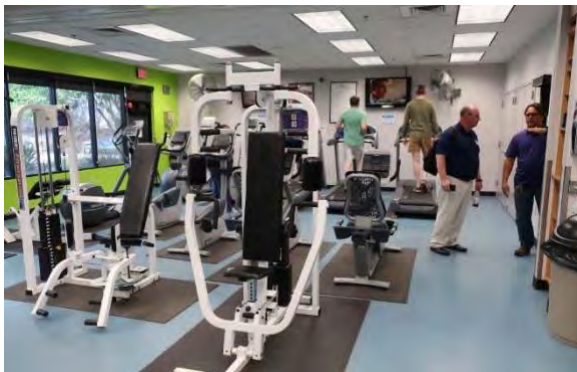
Fitness Center

- **Quantity:** 1
- **Location:** Kiwanis Recreation Center
- **Installation/Renovation:** September 2008
- **Approximate Size:** 26' x 46' (1,196 square foot)
- **Condition Rating:** 4 (above average comparatively for its size)
- **Comments:** The fitness center provides approximately 25 fitness equipment stations. The fitness center is available for recreational use. Equipment includes treadmills (3), recumbent bikes (2), upright bikes (2), weight benches (2), Paramount

Cable System strength training, a Precor cable cross machine, and an array of portable equipment. The adjacent multi-purpose rooms are available for group fitness classes.

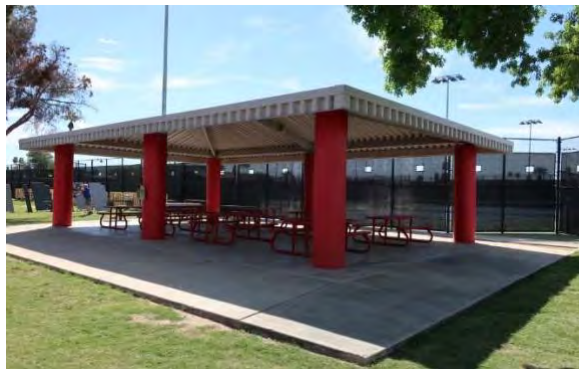
Ramada A (Corporate Ramada and Picnic Area)

- **Quantity:** 1
- **Location:** South of Kiwanis Recreation Center
- **Installation/Renovation:** April 1989
- **Approximate Size:** 28' x 45' (1,260 square feet), which is part of larger 1-acre space
- **Condition Rating:** 3 (average)
- **Comments:** This hipped metal roof ramada includes picnic tables. The ramada is available for recreational use during swimming pool hours and by reservation. Reservation of the Corporate Ramada and Picnic Area includes the use of this ramada, Volleyball

Courts 1 and 2, as well as the surrounding open space. This area is primarily accessible via the pool room.

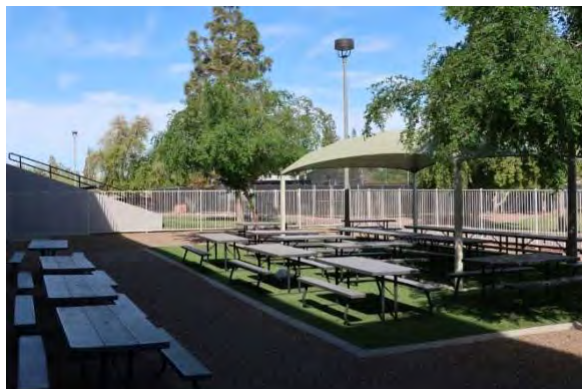
Ramada B (Oasis Ramada)

- **Quantity:** 1
- **Location:** North of Kiwanis Recreation Center
- **Installation/Renovation:** April 2010
- **Approximate Size:** 16' x 25' (400 square feet); 4,000 square feet (larger fenced area)
- **Condition Rating:** 3 (average)
- **Comments:** The Oasis Ramada is a fabric covered ramada that includes picnic tables. The surrounding fenced area provides several other non-covered picnic tables included with the reservation.

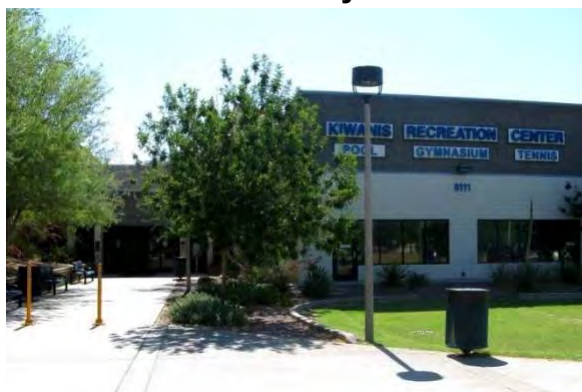
Recreation/Community Center

- **Quantity:** 1
- **Location:** East of All America Way, north of the Tennis Center
- **Installation/Renovation:** 1988
- **Approximate Size:** 52,000 square feet (1st floor), 2,500 square feet (2nd floor)
- **Condition Rating:** 3 (average)
- **Comments:** The Kiwanis Park Recreation Center is open year-round and used extensively for recreation leagues, classes, programs, and events. As with any aging recreation facility over 30 years of age, there are constant maintenance concerns for roofing,

mechanical, plumbing, HVAC, technology, and electrical issues. Storage is very limited, and staff utilize two 8' x 40' mobile containers for additional storage. Additionally, the second floor does not have elevator access.

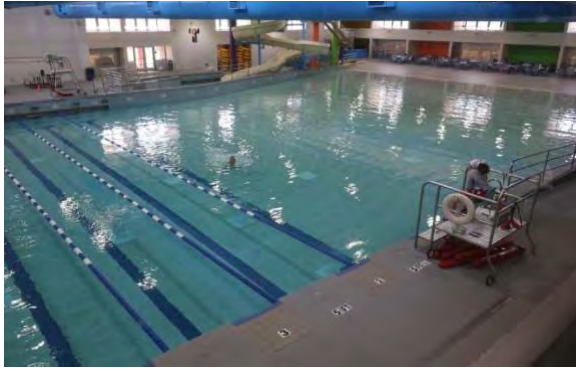
Swimming Pool

- **Quantity:** 1 (includes six lap lanes)
- **Location:** Kiwanis Recreation Center
- **Installation/Renovation:** opened in April 1988
- **Approximate Size:** 26,600 square feet (pool room)
- **Condition Rating:** 4 (above average)
- **Comments:** The Kiwanis Wave Pool is the first and only indoor wave pool in the Valley and is open year-round and used extensively for recreational use (swimming lessons, lap swimming, water fitness, public drop-in swim, etc.). However, the pool's lap

lanes are too short for competitive swimming. The water slide is showing signs of deterioration and requires constant fiberglass and paint touch-ups. The pool mechanical systems are in good working order and the pool room interior walls have been recently painted. The HVAC mechanical system has moderate ability to keep the air fresh within the pool room, even with recent modifications.

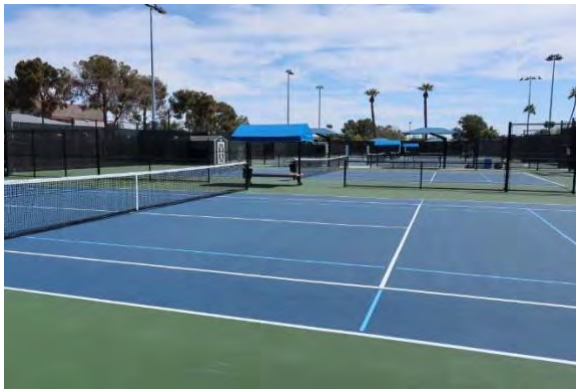
Tennis Center

- **Quantity:** 15 courts full courts (with dual striping for junior tennis) and 2 practice half courts
- **Location:** South of Kiwanis Recreation Center
- **Installation/Renovation:** Renovated in 2019 to replace former asphalt courts with post-tensioned concrete and access space between courts
- **Approximate Size:** 3.1 acres (total fenced enclosure)
- **Condition Rating:** 5 (significantly above average)
- **Comments:** Court orientations are north-south, which is ideal. New LED lighting was installed as well as a PlaySight™ Smart Courts video system. The

courts are available for recreational use, league play, tournaments, and by reservation. Support amenities include a ramada, picnic tables, spectator shade, court cabanas, bleachers, and a restroom.

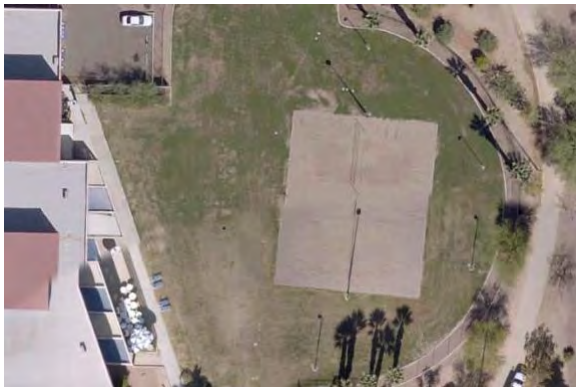
Volleyball Courts 1 and 2 (KRC Volleyball: North and South)

- **Quantity:** 2
- **Location:** East of Kiwanis Recreation Center (in the Corporate Ramada and Picnic Area)
- **Installation/Renovation:** Unknown
- **Approximate Size:** 7,900 square feet (total sand area)
- **Condition Rating:** 3 (average)
- **Comments:** These sand courts are lighted for night-time use and include a court watering system. These courts are oriented east-west, though the ideal solar orientation for courts is north-south.
