**CITY OF TEMPE
HISTORIC PRESERVATION COMMISSION**

Meeting Date: 05/11/2022
Agenda Item: 6

ASSESSMENT OF THE HISTORIC ASH AVENUE ROADWAY and ABUTMENT Tempe Arizona

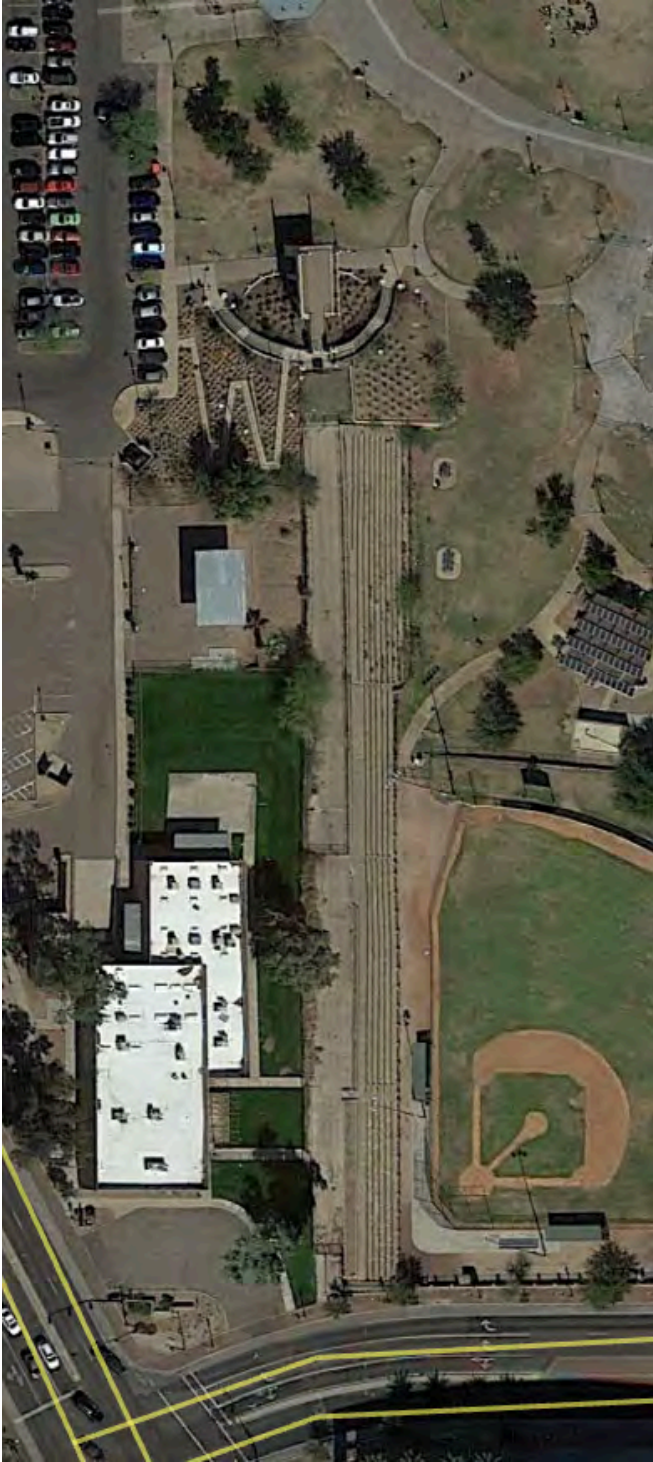
*fig. (1)
Google view of site showing Ash Ave roadbed and
bridge abutment at Tempe Beach Park,
ballpark and bleachers. ca. 2018*

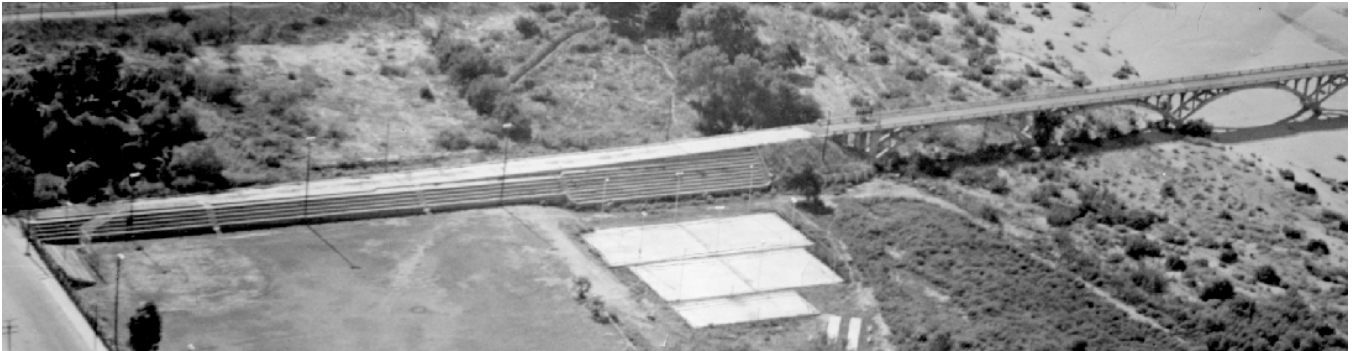
fig. (13)

A portion of the 1935 HABS HAER aerial photograph showing the approach, bleachers and bridge.

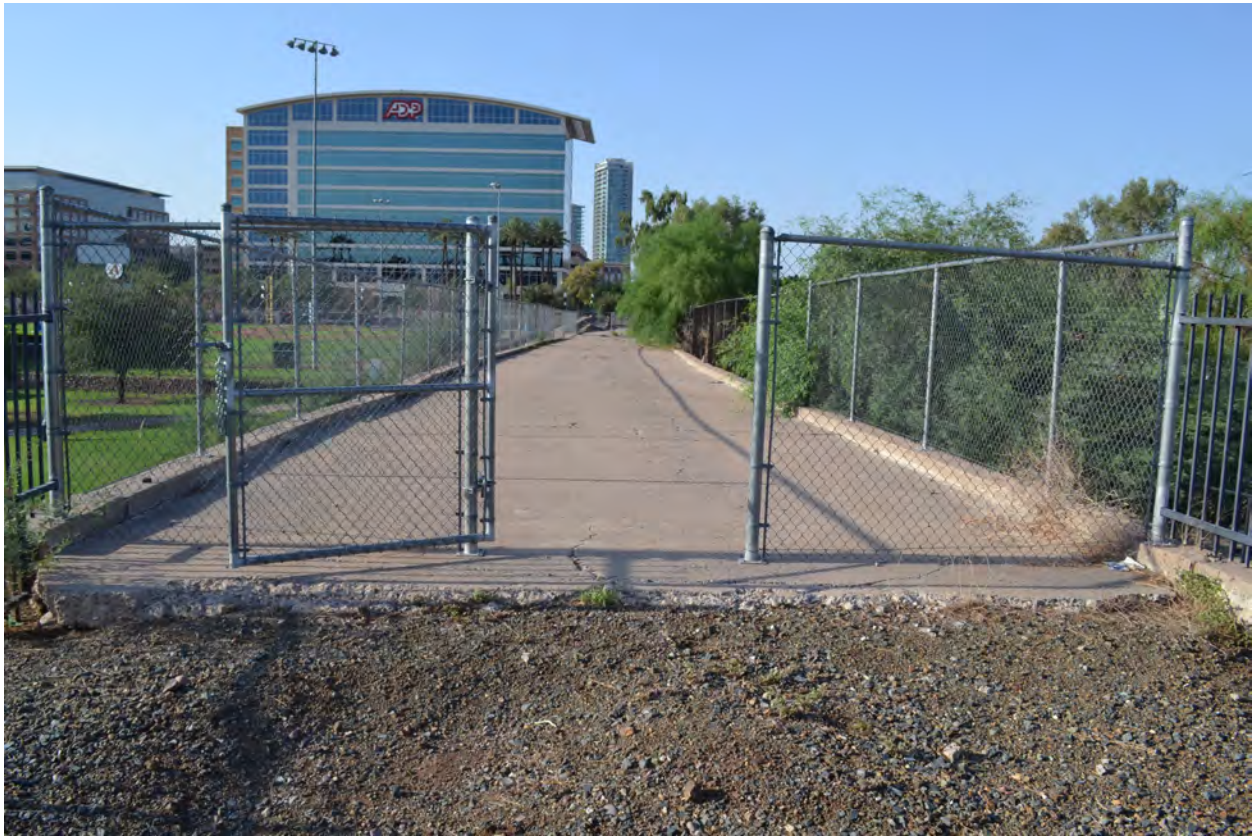
fig. (14)

Existing concrete roadbed from north end through existing fencing securing roadbed access. Road has been demolished from this location to the bridge abutment to keep any unauthorized vehicular access to roadbed. photo credit Mark Vinson August 2018.

(14), has been added to all four sides of the roadbed to secure the roadbed and protect it from any vandalism or damage. Curbs are the original historic curbing approximately 5"x12" with original 8"x 8" bollards still showing in the curbs at multiple locations (approximately 45 on west side and some remaining on the east curb) at 8'-0" on center, fig. (15). There are some indications of bollards on the east curb also, fig. (16). The fencing's vertical supports have been attached to the curbs in various ways and any damage will have to be repaired once removed. The actual roadbed surfacing is the original concrete paving placed ca. 1920.⁵² Roadbed width varies from 16ft to 20ft in width, due to bleacher construction in the 1930s, fig. (17). See Entellus survey document. The roadbed surface is in various stages of decay as shown in figs. (18-23). Moisture has penetrated the paving and caused heaving, cracking and spalling of the concrete. The original paving has settled in several areas due to moisture penetrating the roadbed at areas where the curbing has moved away and differential settlement has occurred between the curb and roadbed.

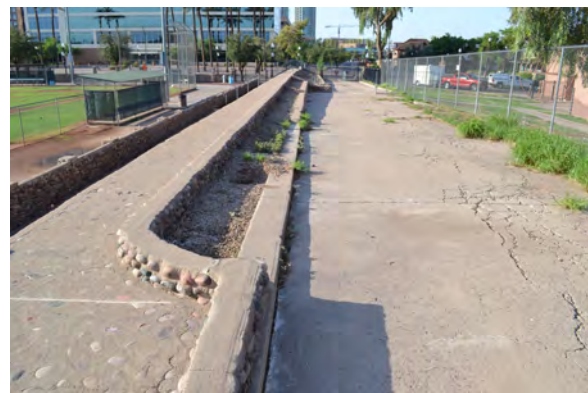
fig. (16)

Several areas of the roadbed have completely separated from the curb as there was never any connection between the curb and paving section. Vegetation has penetrated the roadbed and caused heaving of sections of roadbed where this has occurred. In other areas the roadbed is completely missing and vegetation has replaced the roadbed.

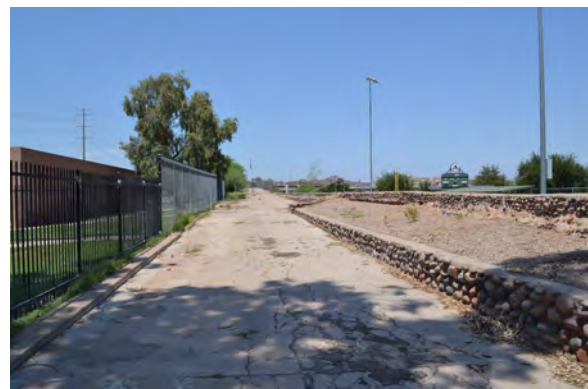
fig. (17)

Where the bleachers were added in 1930s on the east slope of the roadbed, the transition from bleachers to roadbed has fared better. The condition of the bleachers was not part of this report but several intersections of the roadbed and the bleacher area will need to be looked at carefully, due to

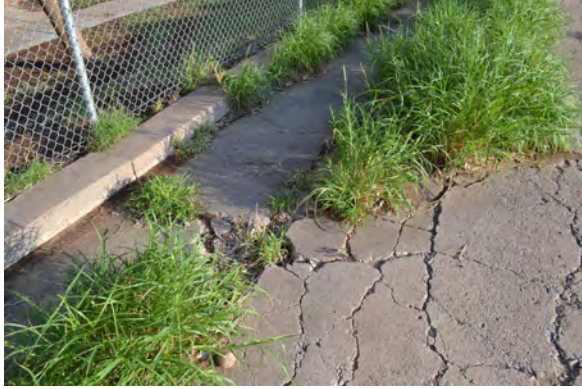
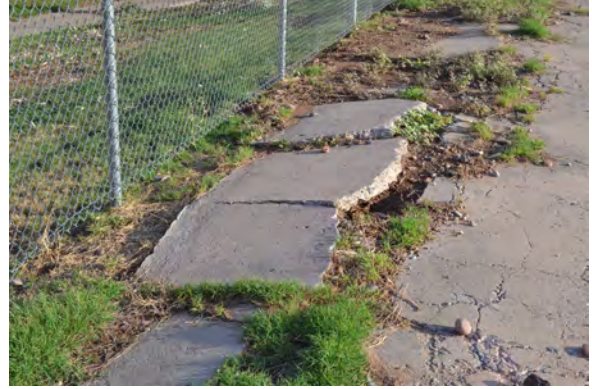
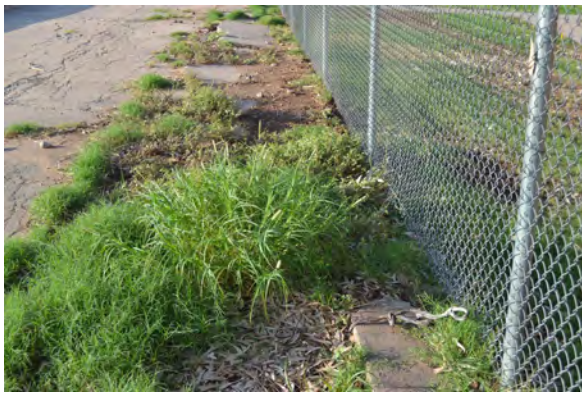
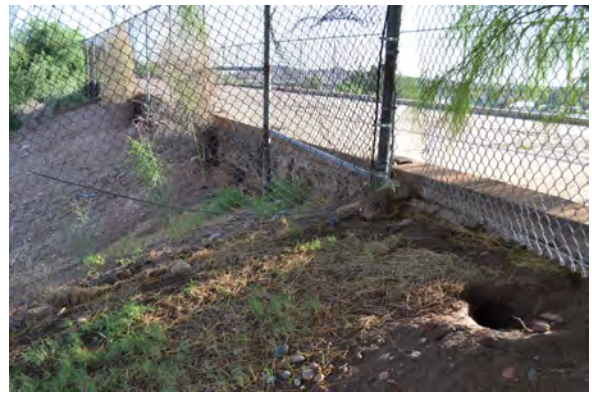
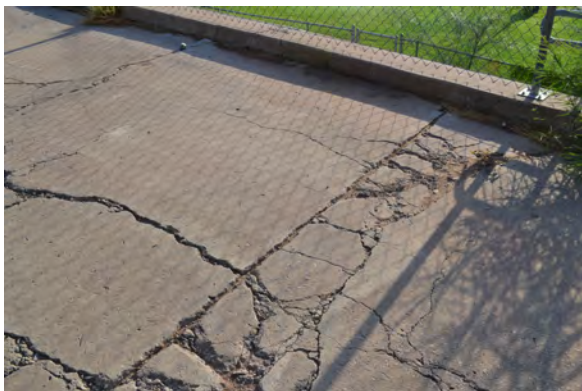
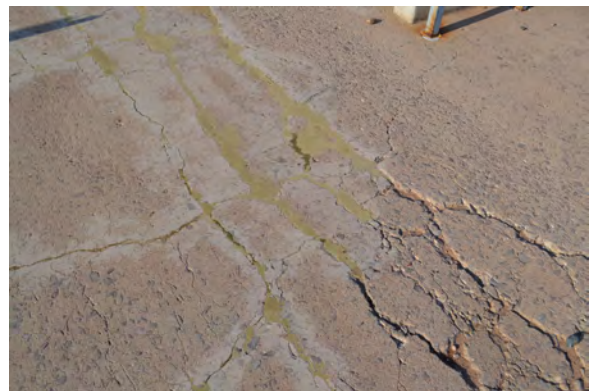
figs. (18-23)

Photos above show the deterioration of the pavement of the historic roadbed. Multiple areas have heaving pavement sections, damage from vegetation intrusion, animal burrows and poor repairs in the past.

Animal burrows are providing access for moisture and intrusion under the roadbed causing additional deterioration and settlement, fig. (21). Other areas of the roadbed have received incomplete or less than sufficient repairs, fig. (23), while other areas have been completely ignored and allowed to continue to deteriorate, fig. (22).

- Clean the existing concrete surface and cracks until clear of all debris or loose material.
- Any areas that have large separation gaps between the roadbed and the existing curbing should be filled in with non-expansive grout prior to placing of the vapor barrier.
- Place a minimum 20mil thickness of vapor barrier/plastic membrane overlaying the concrete approach slab. The barrier must have all seams and penetrations sealed per manufacturers recommendations and should be place in accordance with ACI 302.2R.
- Place geotextile fabric (MAG 796.2.2 Class A) over the vapor barrier and anchor the sides into the inside edge of the curbs.
- Place a single 2-inch layer of Portland Cement concrete (lean mix) topping along the entire length of the roadbed.

- Replace areas of missing pavement with new 3" concrete paving sections. Dowel new concrete sections into the existing paving.
- Replace areas missing curbing with curbing to match in size and shape the historic curbs. New concrete will identify it as not historic.
- Place new vegetation on sloped areas after installation of the retaining walls on the west slope of the ROW, fig. (32).

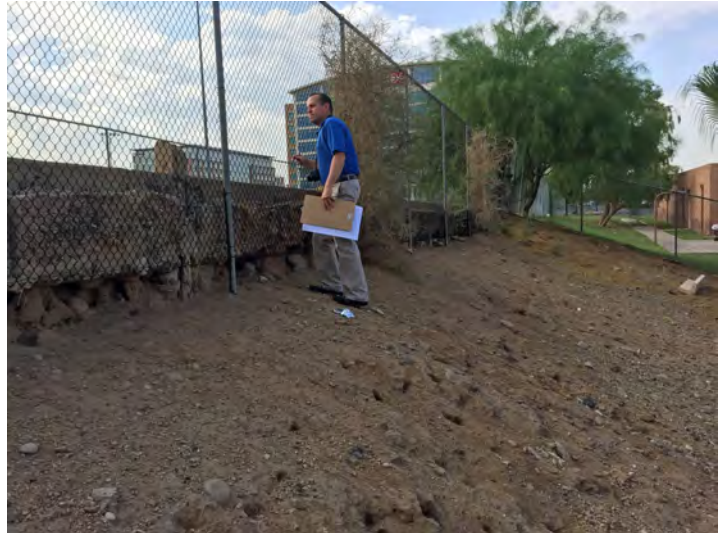
fig. (24)

West slope of roadbed ROW showing vegetation has been removed. Concrete roadbed exposed.

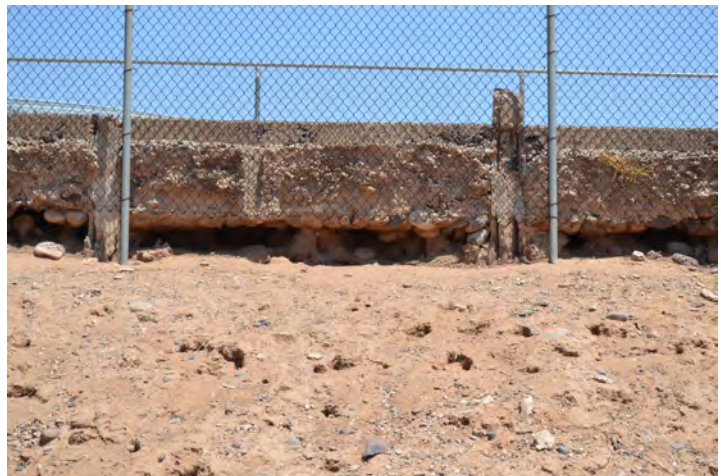
fig. (25)

Visible erosion of roadbed along west slope. 2018

- Construct a variable height retaining wall along the west slope of the ROW from the northernmost limit of the roadbed to the old sidewalk access to Penny Saver property.
- Inject/fill voided sections of the west slope with flowable injectable grout, lean mix, or controlled low strength material, (CLSM), to replace loss of subgrade and prevent further settlement and distress.
- Remove and protect against regrowth of all vegetation on the approach surface and between the approach and curbing and balustrade.

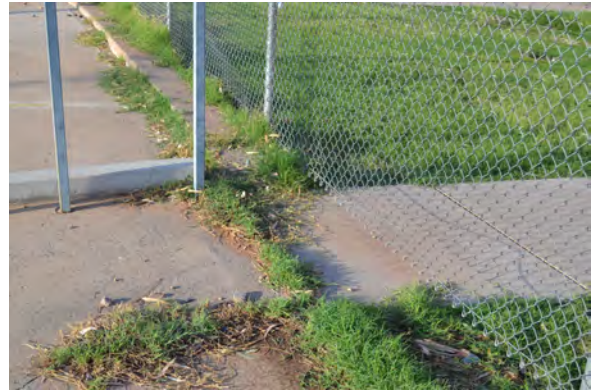
fig. (26)
Historic curbing has been removed to allow sidewalk access from Pennysaver site.
Photo 2018.

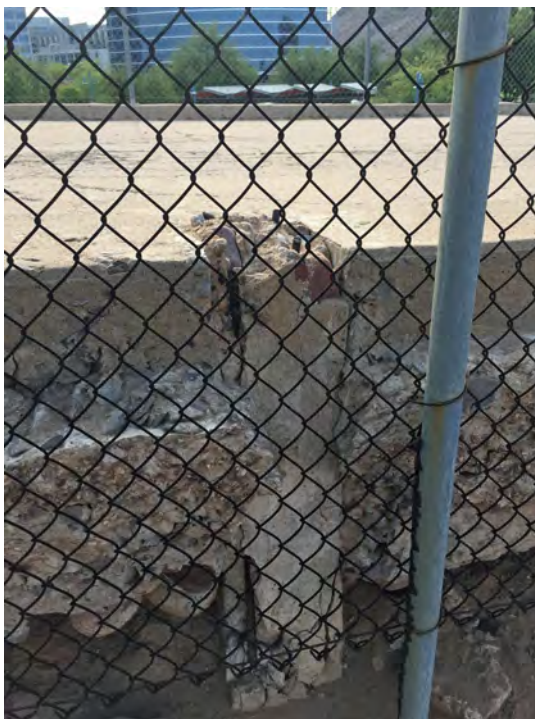
fig. (29)
Historic roadbed bollard on west curb showing penetration of roadbed and erosion of roadbed subbase material.
Photo 2018.

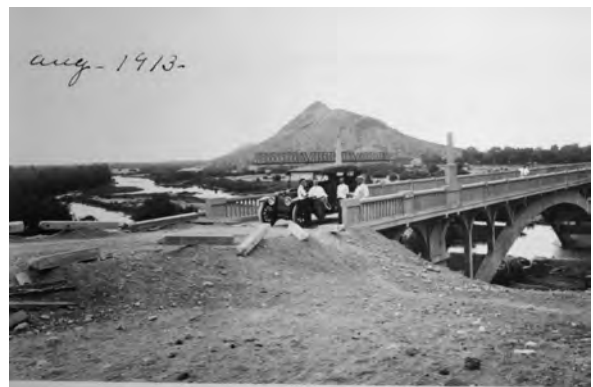
fig. (27)
HABS HAER photo ca. 1913 showing Ash Ave Bridge west side bollard installation.

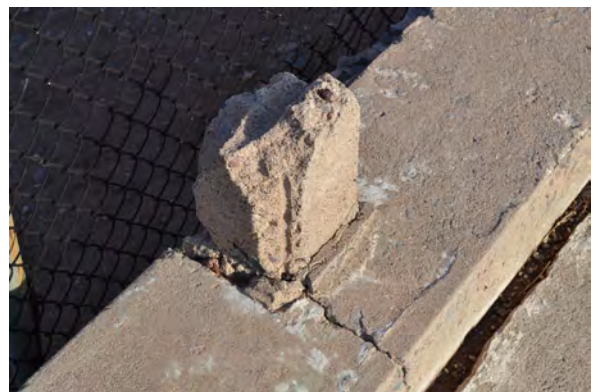
fig. (28)
Remaining piece of historic bollard on west curbing. Note gap between road and curb.
Photo 2018.

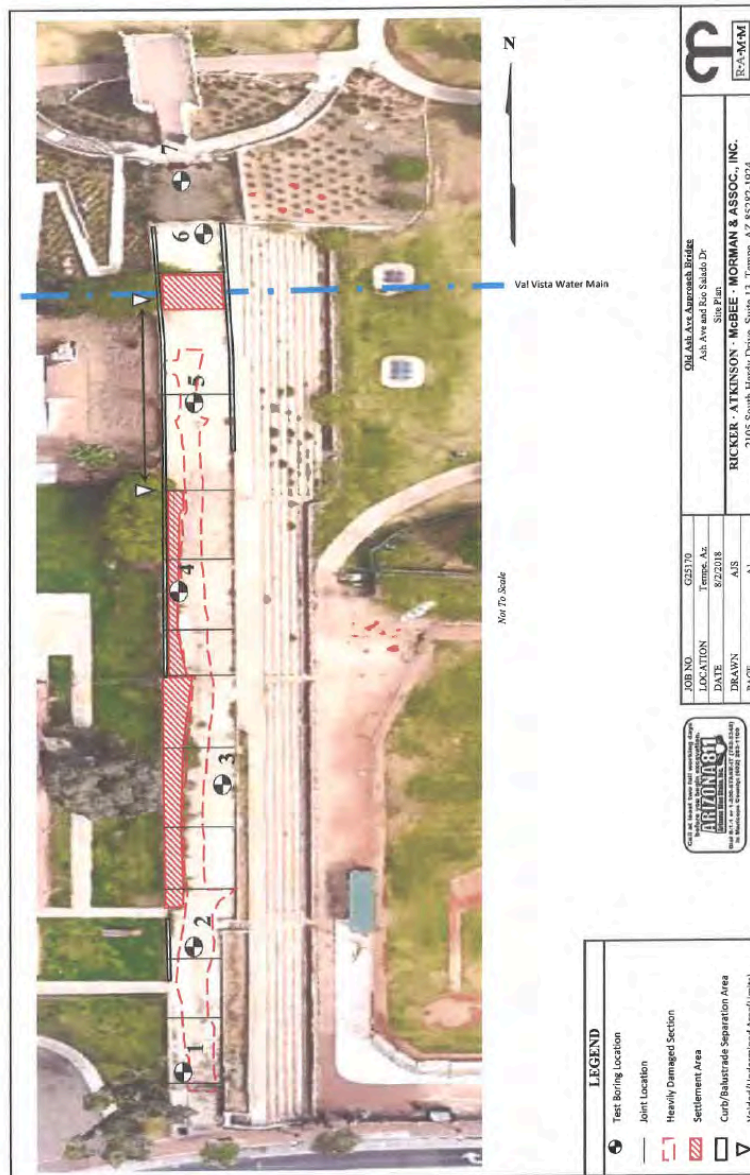
RAMM Engineering and is an attachment to this report. It shows that the subgrade material is compacted gravel, maintaining its structural integrity except where it has been undermined by water erosion. Fig. (30) shows limits of report.

fig. (30)
 Figure from RAMM geotech report showing areas of work.

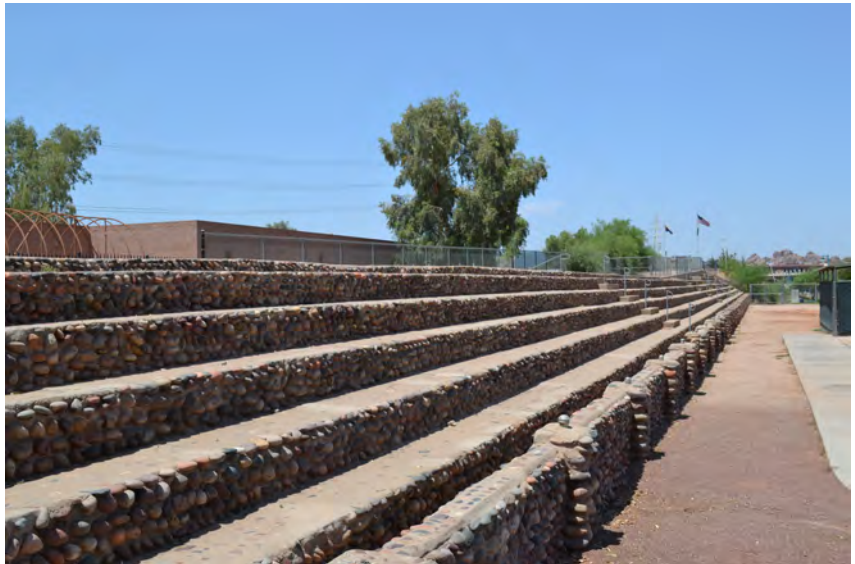
*fig. (31)
Existing Bleachers at Tempe Park 2018*

The **roadbed right-of-way (ROW) cross section should also be maintained.** The east slope is still visible even though the “historic stone bleachers” are now part of that slope, fig. (31). The west slope is still in its original location and maintains its dimensional integrity. Any intrusion into the west ROW would impact its visual character defining features.

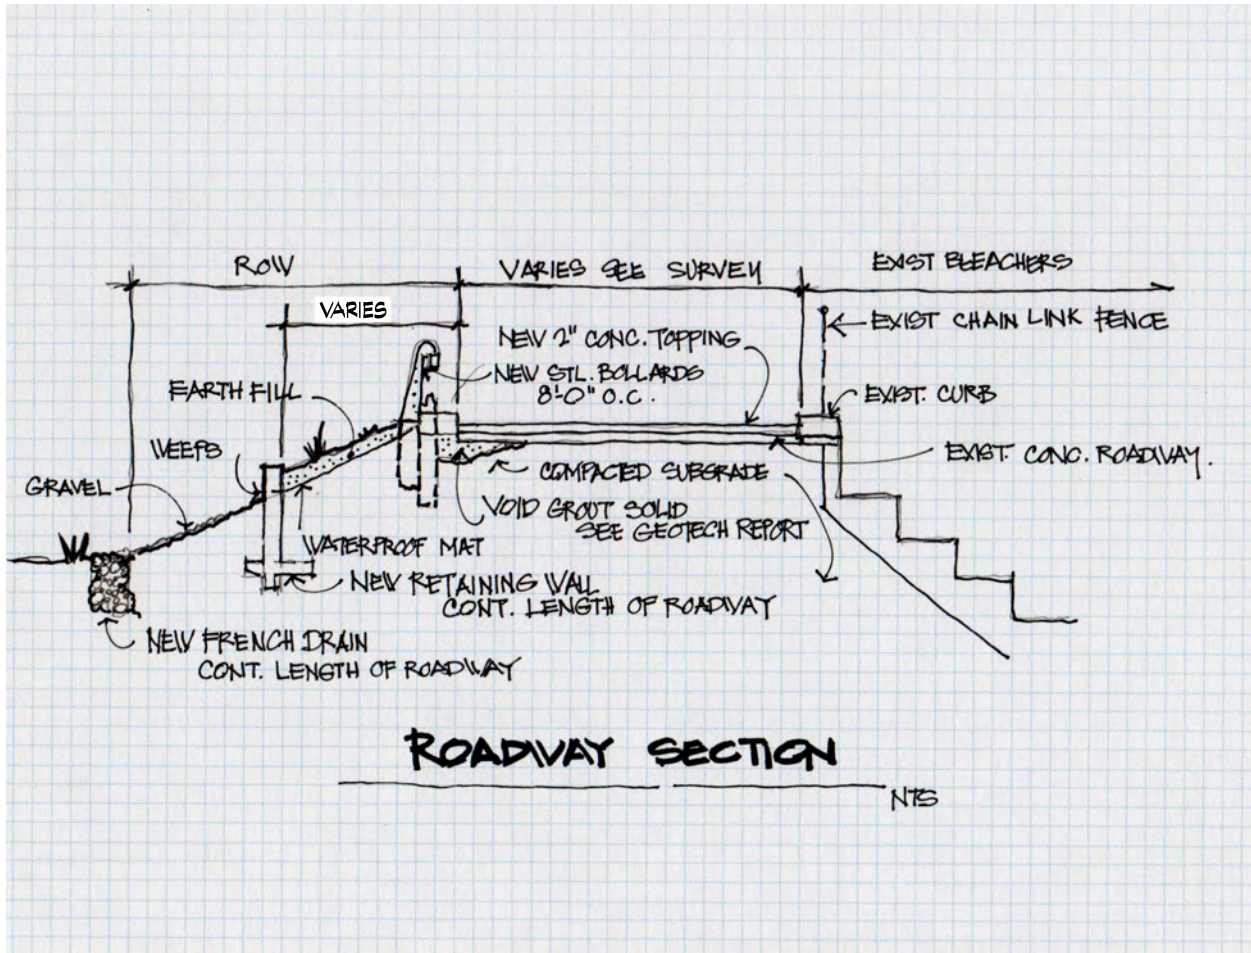
fig. (35)
Cross section of roadbed showing renovation concepts.

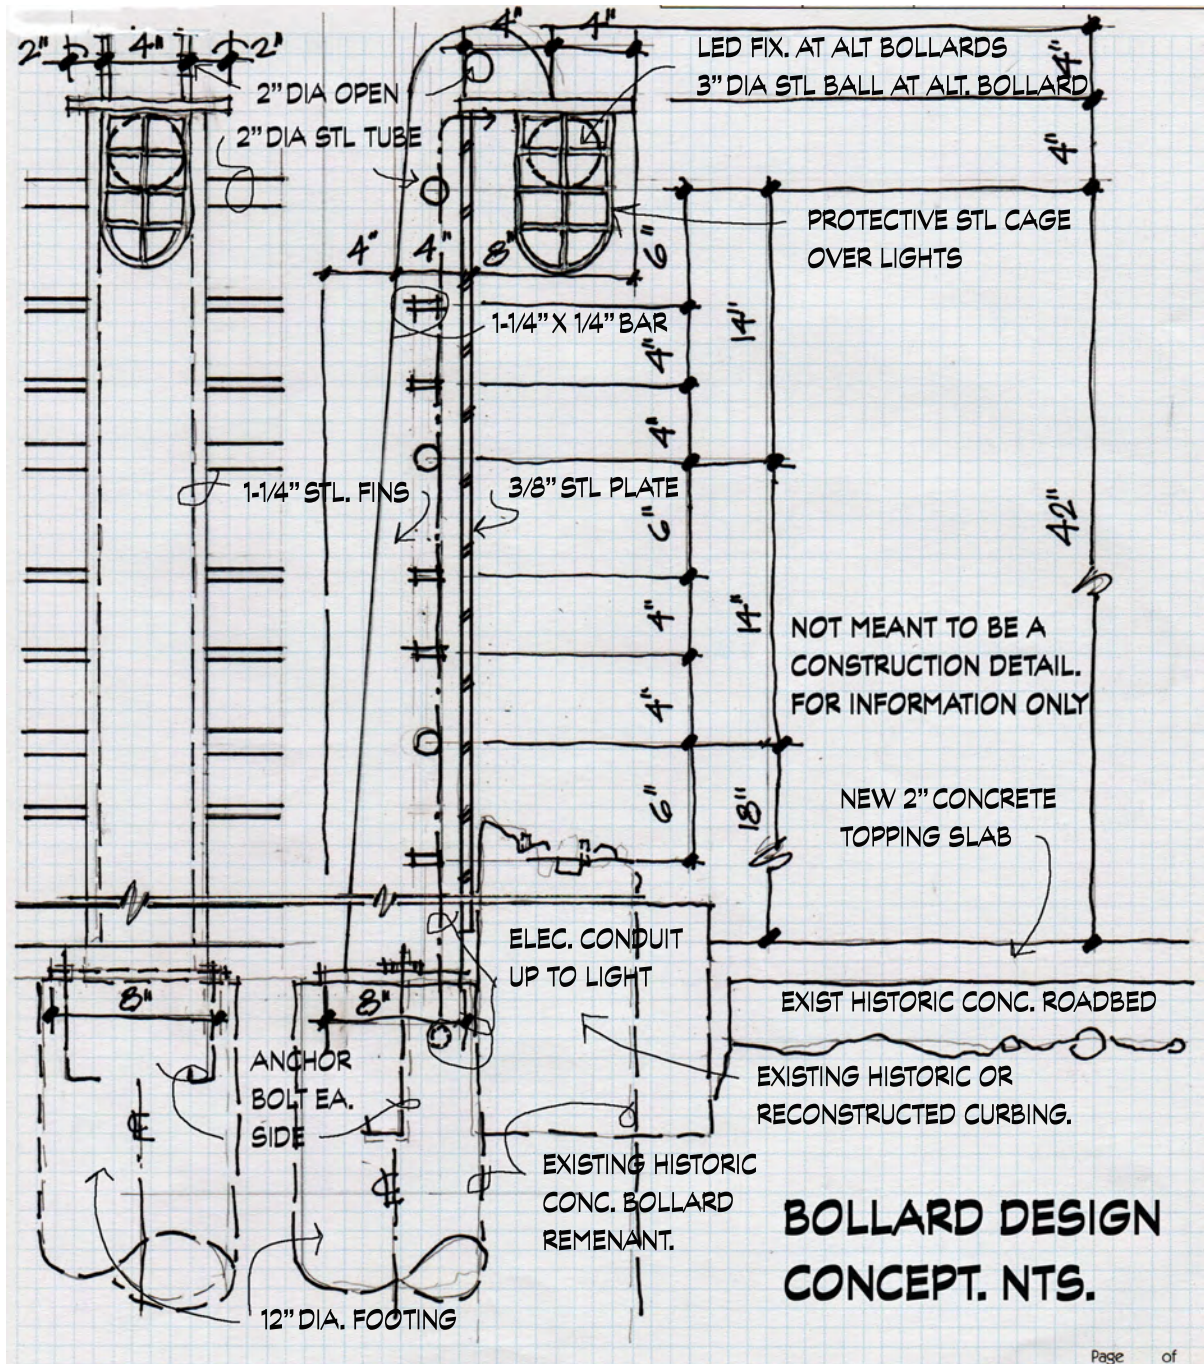
fig. (36)
New bollard concept sketch.

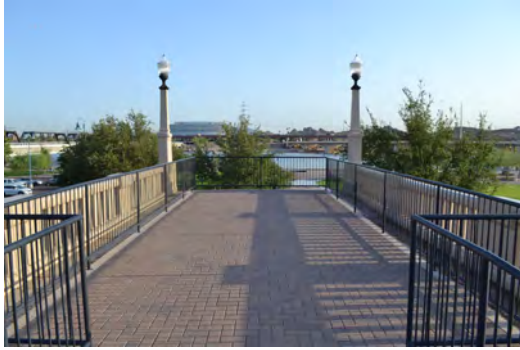
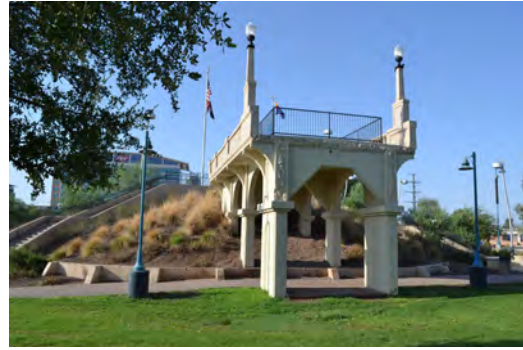
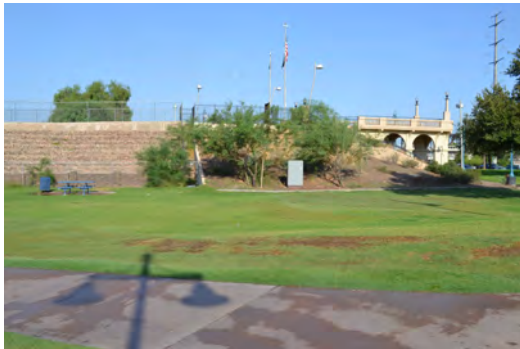
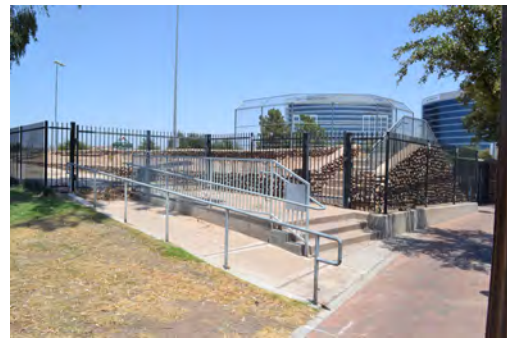
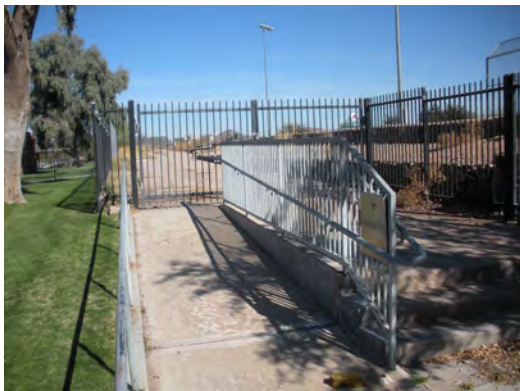
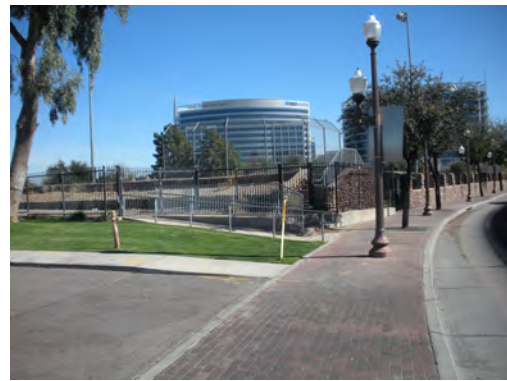
fig. (47)
Modern photographs of site study area.

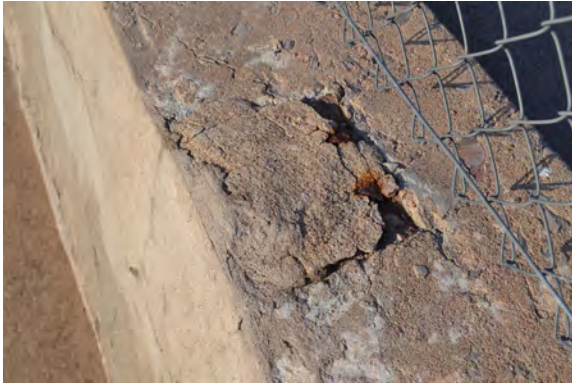
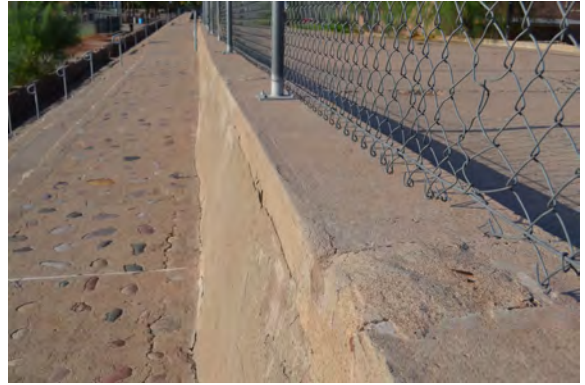
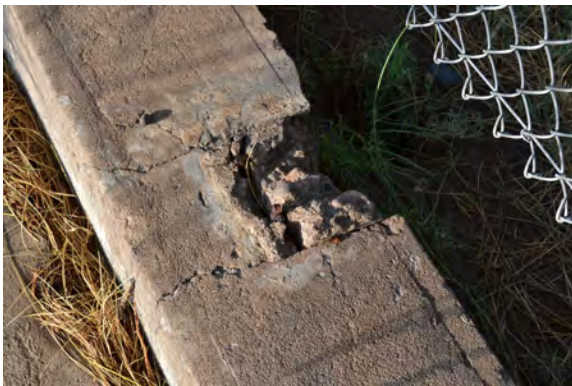
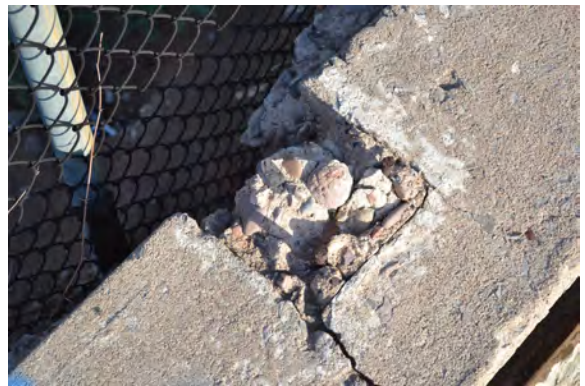
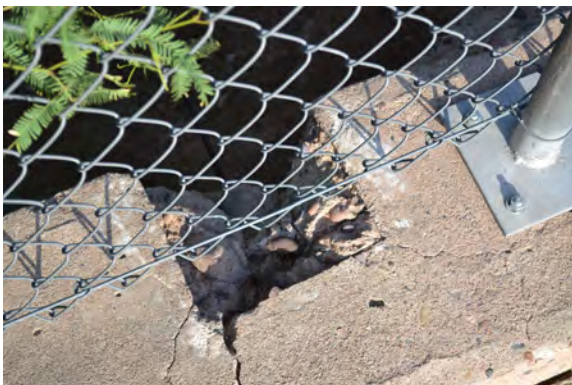
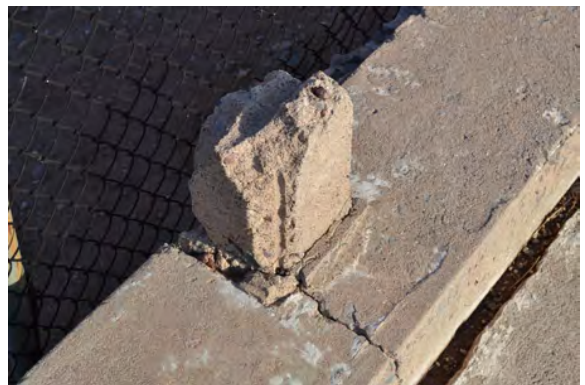
fig. (48)
Modern photographs of bleachers and east slope.

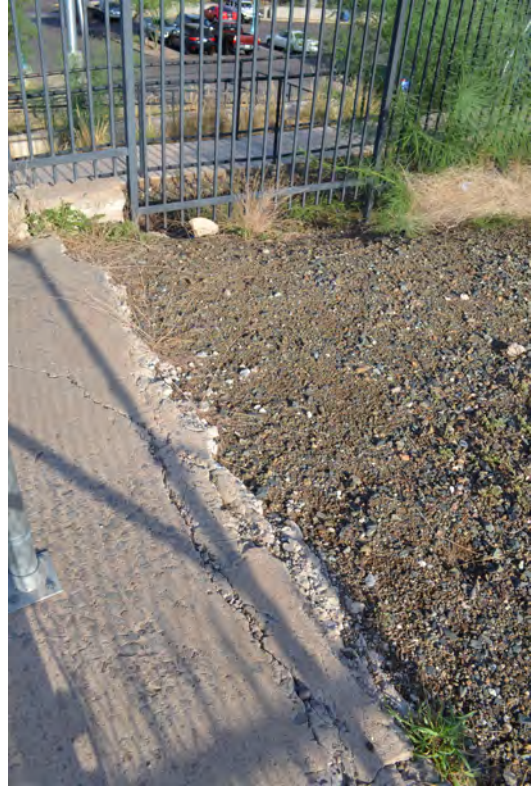
fig. (50)
Modern photographs of existing roadbed surfaces.

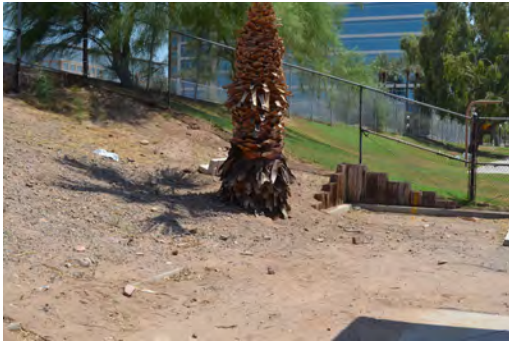
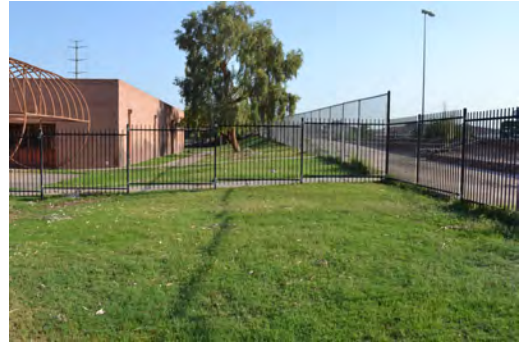
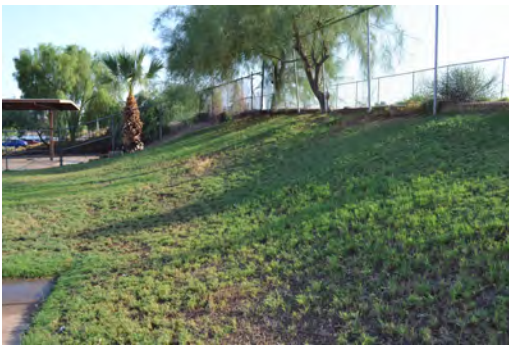
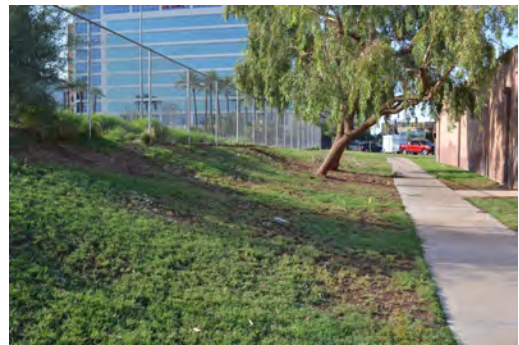
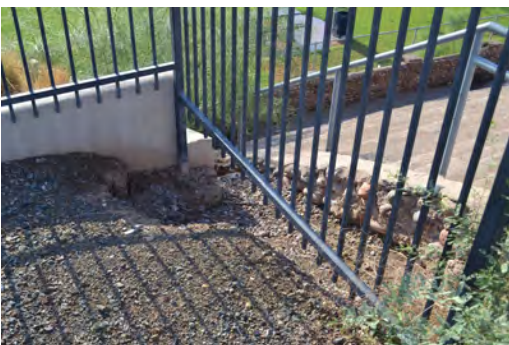
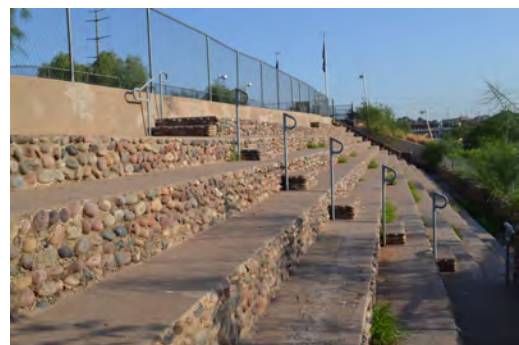
fig. (51)
Modern photographs of roadbed curbing and
sidewalks.

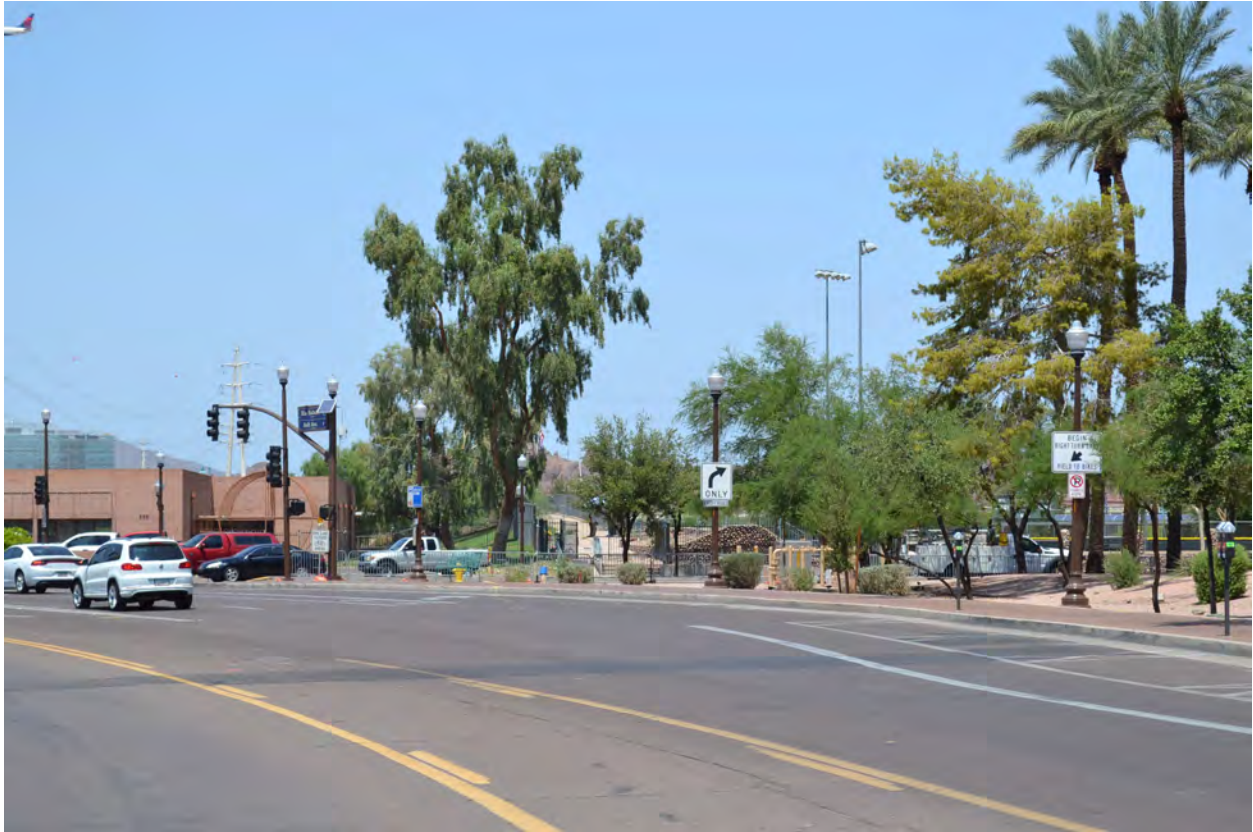
fig. (53)
*View of Ash Avenue bridge approach from the south
on present day Ash Avenue.*

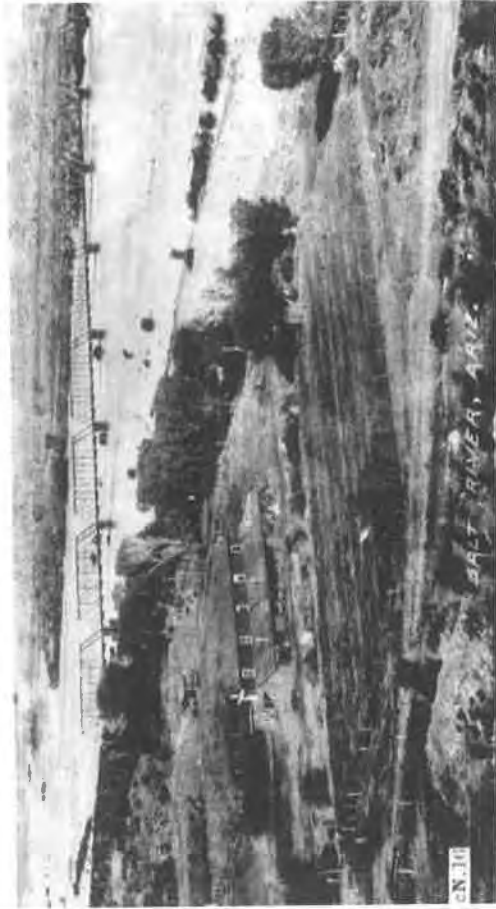
HAER No. AZ-29-7

Looking east from an undetermined elevated position at the south approach (during construction) Circa 1912. (HAER No. AZ-29, No. AZ-29-7)

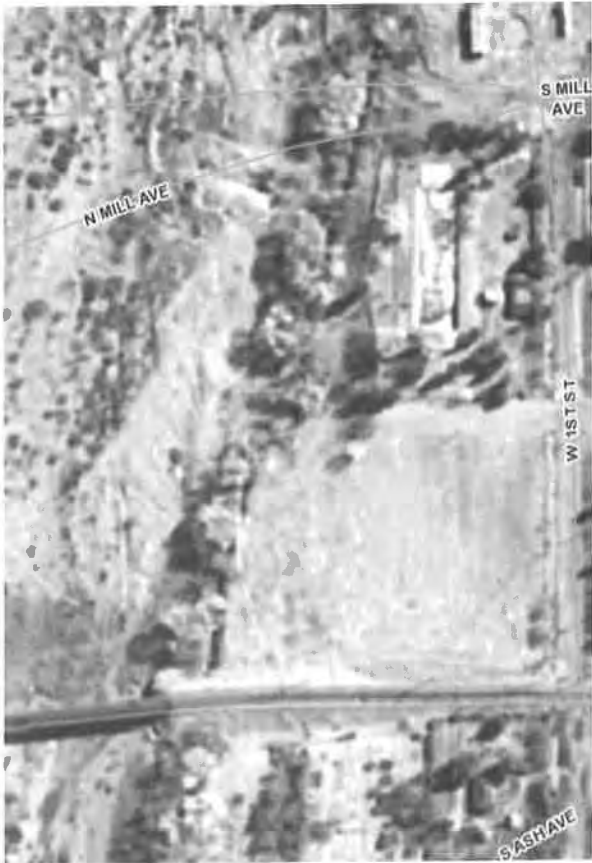
Oblique aerial photograph of Tempe Beach Park post construction of the cobble bleachers and Mill Avenue Bridge. Circa 1935. (Tempe From Above, No. 1987.1.2288, Tempe History Museum)

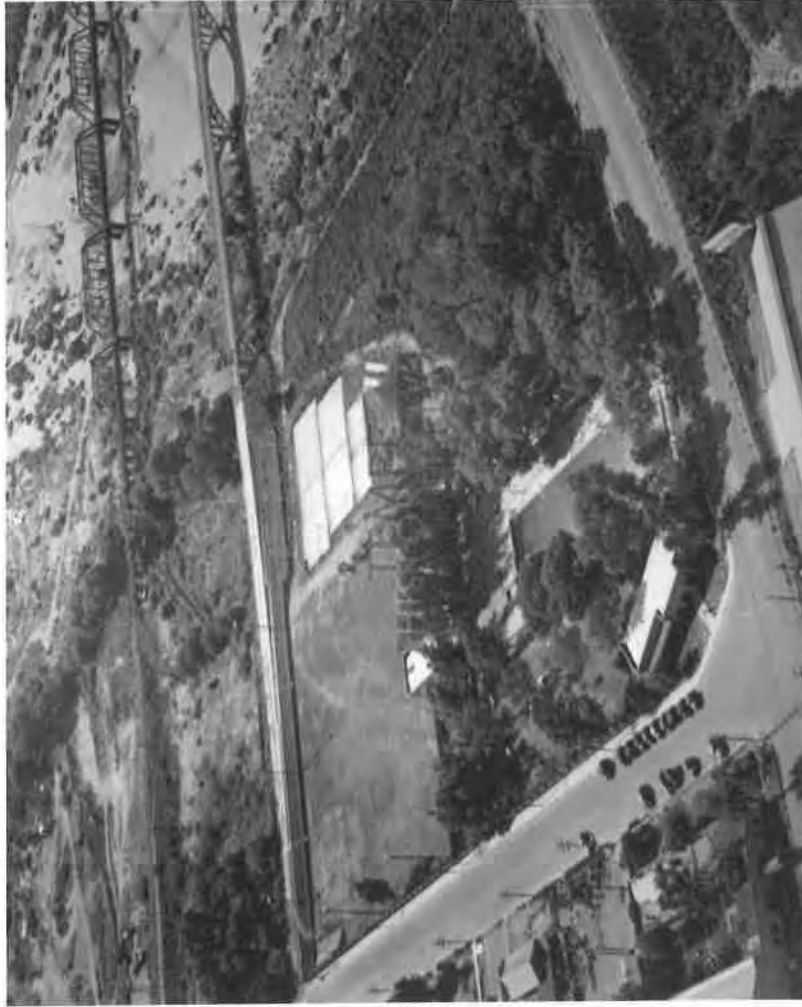
Aerial photograph of the Ash Avenue (Tempe) Bridge prior to construction of the Tempe Beach Park cobble bleachers and walls and Mill Avenue Bridge. (Historic Aerial Photography, Maracopa County GIS, 1930)

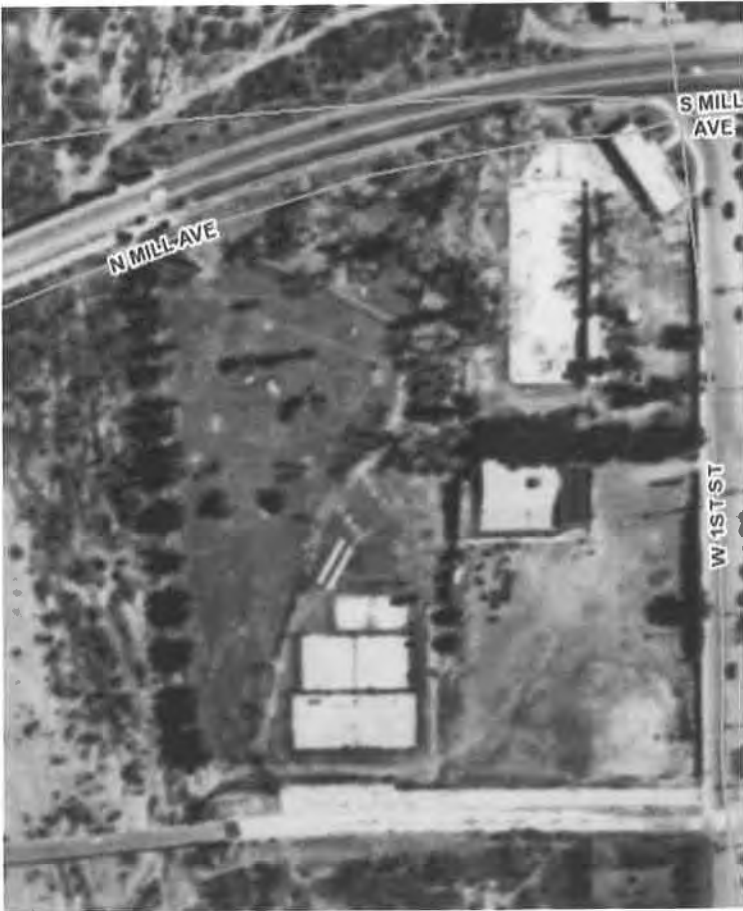
Oblique aerial photograph of the west slope of the Ash Avenue (abandoned) bridge approach prior to development. Circa 1977. (Tempe From Above, No. 2000.20.218, Tempe History Museum)

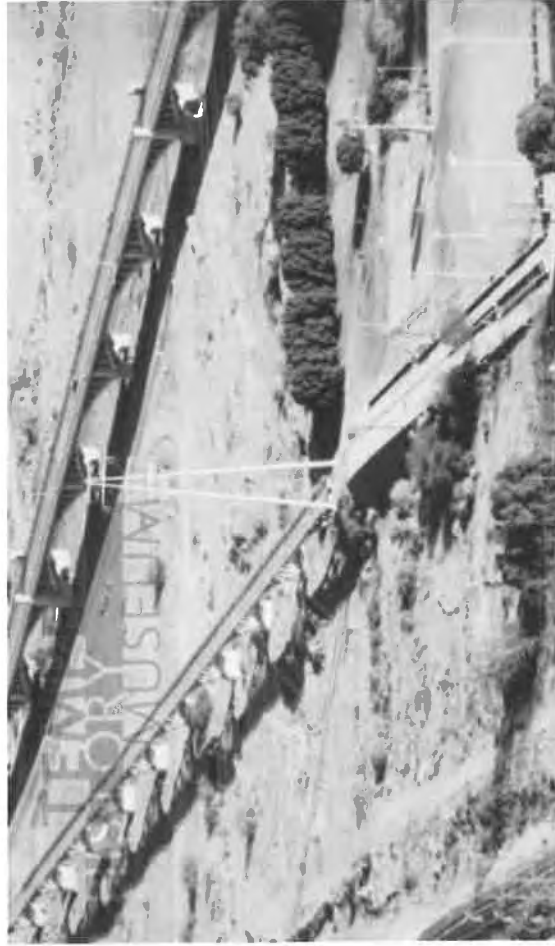
JOB NO.	G25170
LOCATION	Tempe, Az
DATE	8/2/2018
DRAWN	AJS
PAGE	DI-3

Aerial photograph of the Ash Avenue (abandoned) Bridge and Mill Avenue Bridge with Tempe Beach Park filling the space between. (Historic Aerial Photography, Maricopa County GIS, 1949)

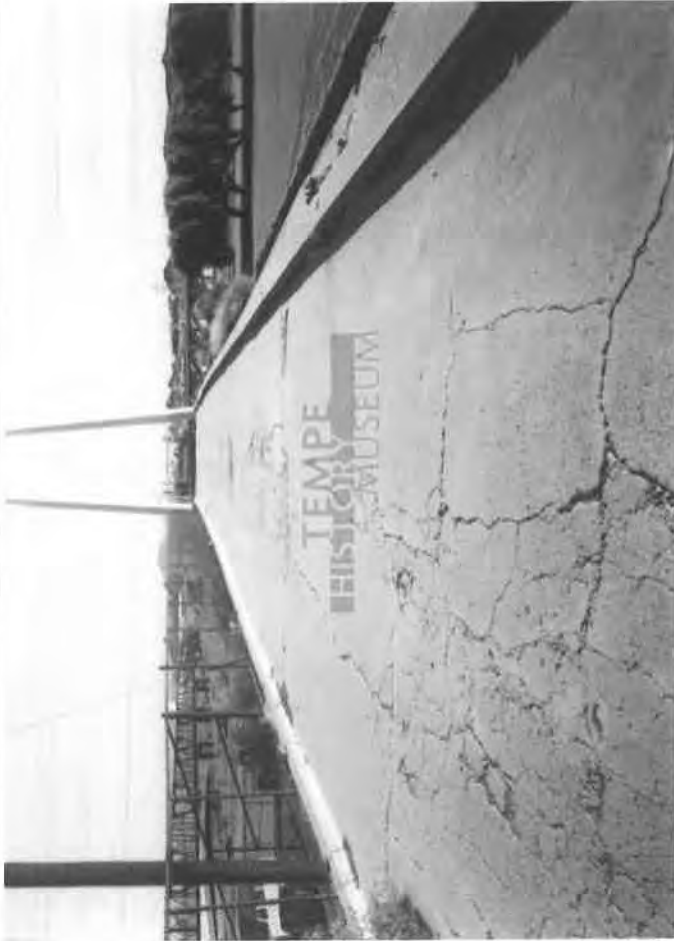
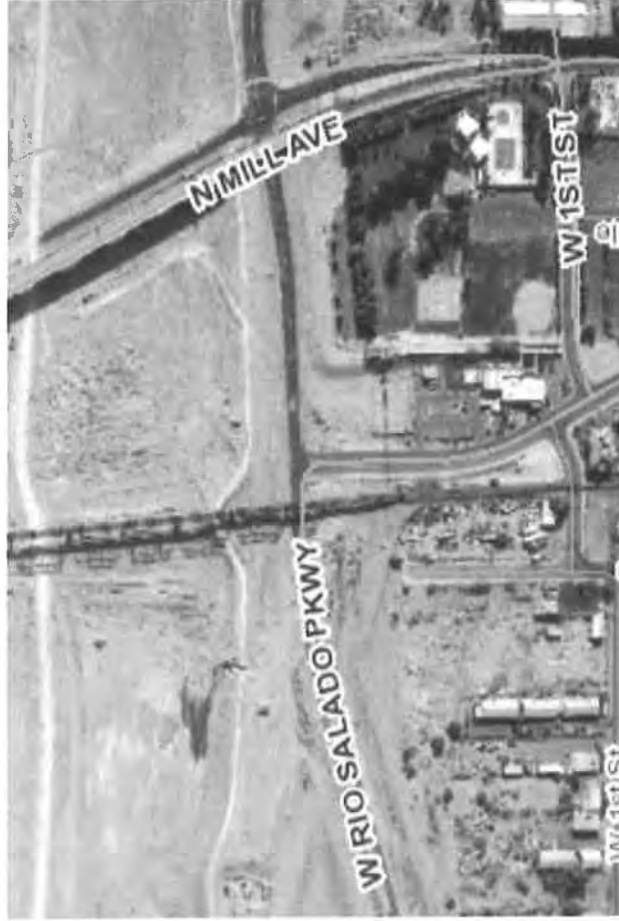
JOB NO.	G25170
LOCATION	Tempe, Az
DATE	8/2/2018
DRAWN	AJS
PAGE	D1-4

Aerial photograph of the Ash Avenue (demolished) Bridge and Mill Avenue Bridge with Rio Salado Parkway along the north edge of the park. Photograph taken during construction of the flood control levees and Tempe Town Lake (Historic Aerial Photography, Maracopa County GIS, 1991)

Top perspective looking north of the Ash Avenue (abandoned) bridge south approach prior to demo. Circa 1990. (Tempe From Above, No. 2016.20.12, Tempe History Museum)
