**CITY OF TEMPE  
HISTORIC PRESERVATION COMMISSION**

**ACTION:** Request for approval of a motion in support of rehabilitating the Historic Eligible and National Register-listed Gonzales-Martinez House, located at 321 West 1st Street.

1. 2017 Building Condition Assessment Report for the Gonzales-Martinez House completed by Motley Design Group, LLC

**A Building Condition  
Assessment of the**

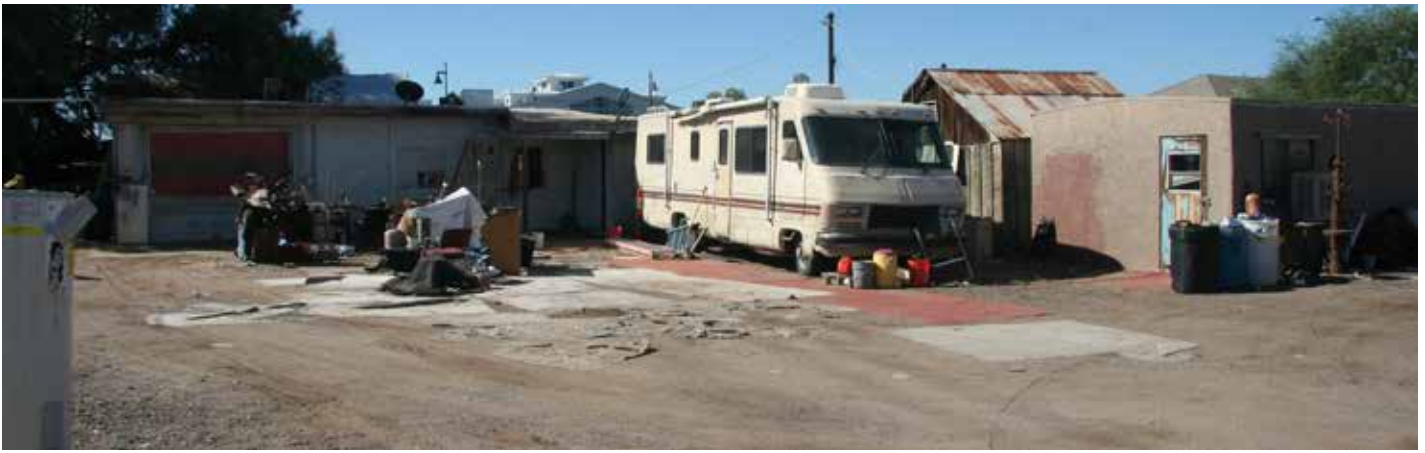
*Overall view to southwest. Shack (with metal roof) at right*

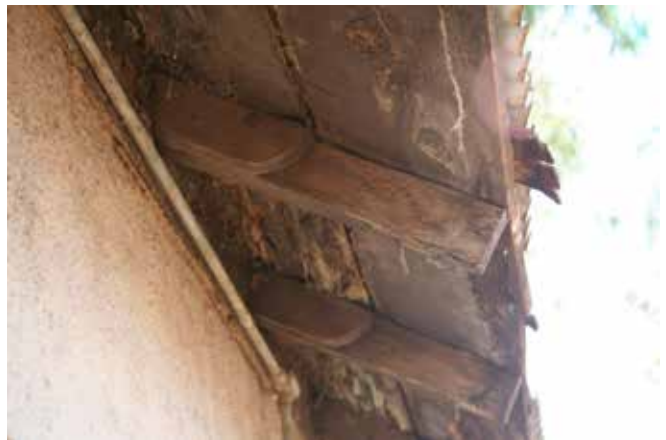
*South Eave Close up*

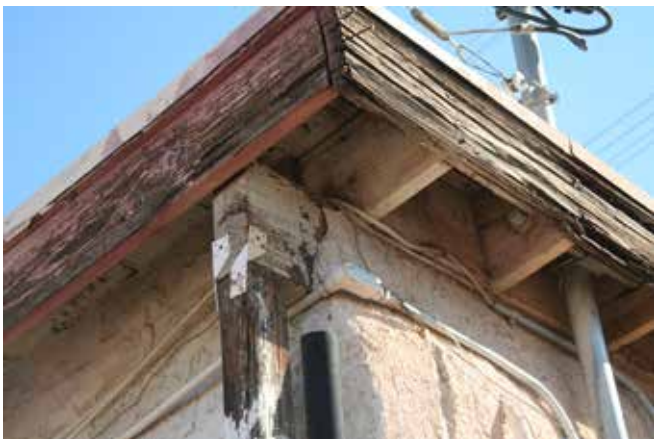
*Eave at South West Corner*

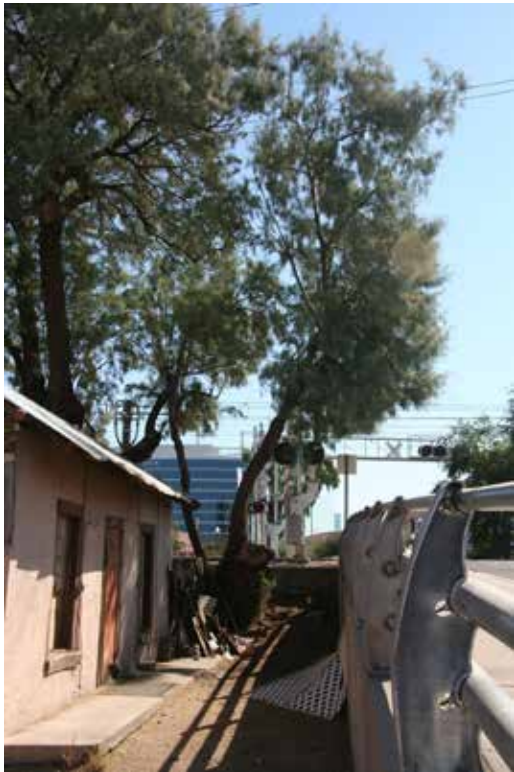
Areas of potential water retention close to adobe and wood foundation walls exist along the east and south sides of the house.

*South Yard to East*

Conduct a detailed topographic survey for the site in order to verify drainage patterns. If found to be necessary, re-grade the site to eliminate any standing water within 10 feet of the exterior foundation walls.
