**CITY OF TEMPE  
HISTORIC PRESERVATION COMMISSION**

**ACTION:** Request for approval of a motion in support of rehabilitating the Historic Eligible and National Register-listed Gonzales-Martinez House, located at 321 West 1st Street.

1. 2017 Building Condition Assessment Report for the Gonzales-Martinez House completed by Motley Design Group, LLC

**A Building Condition  
Assessment of the**

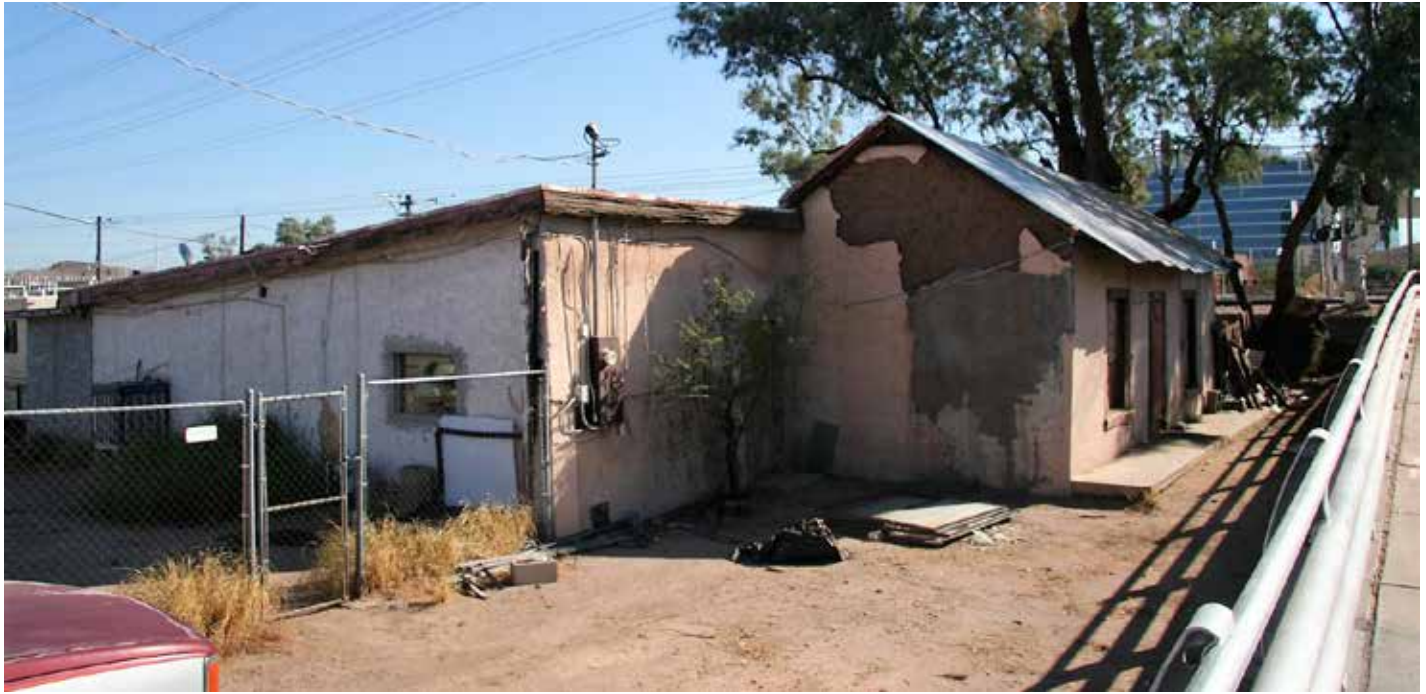
*General View to North East*

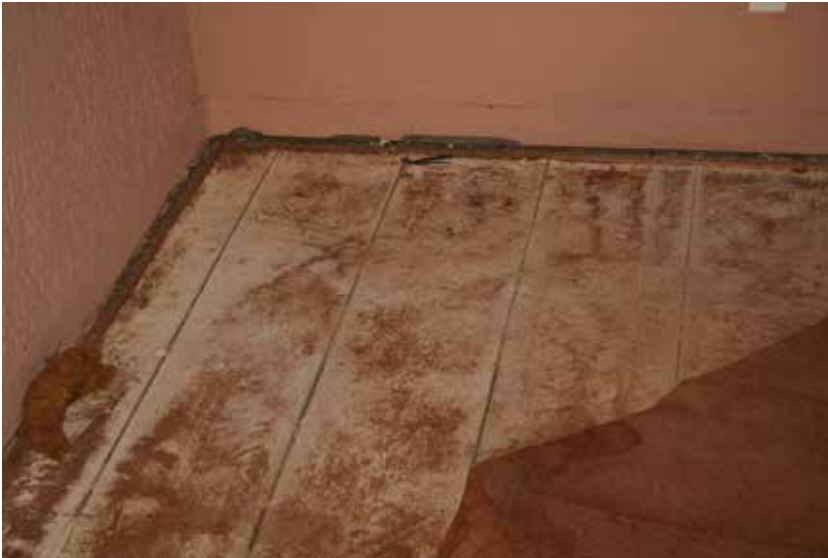
*Floor Damage*

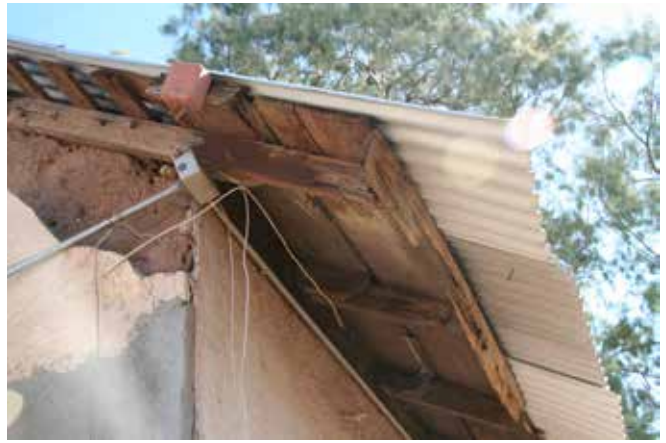
*South Eave*

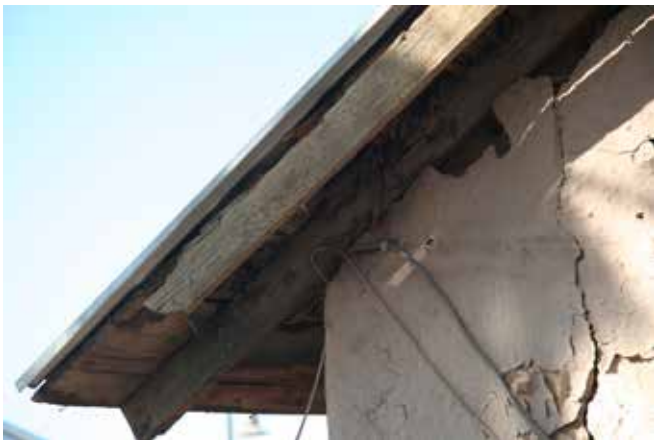
*East Fascia*

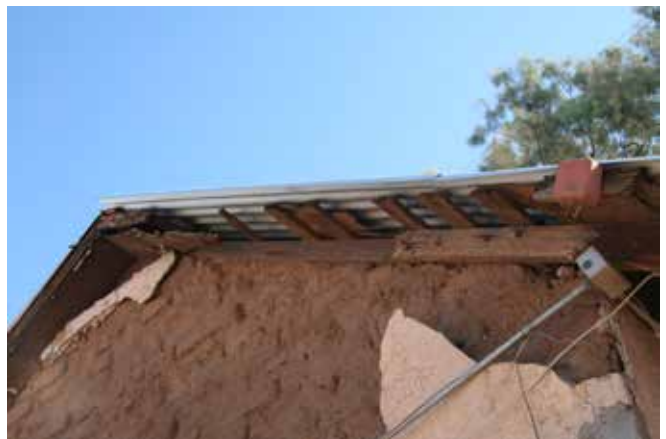
*West Gable*

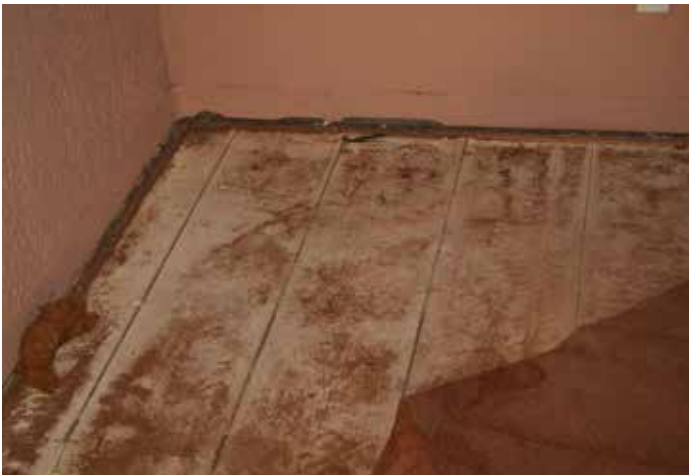
*Wood Flooring*

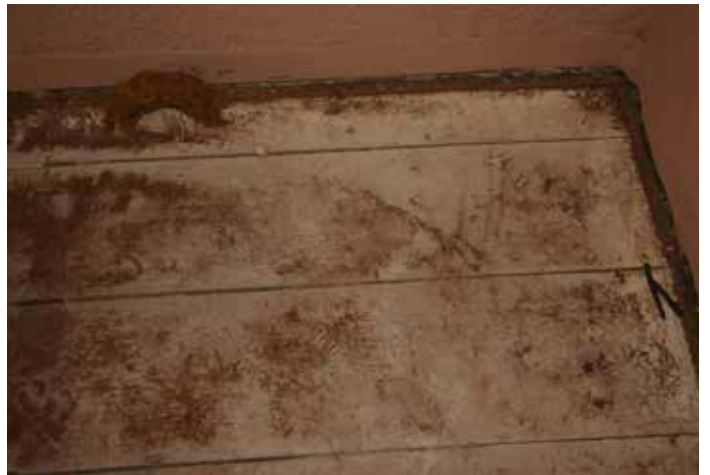
*Wood Flooring*

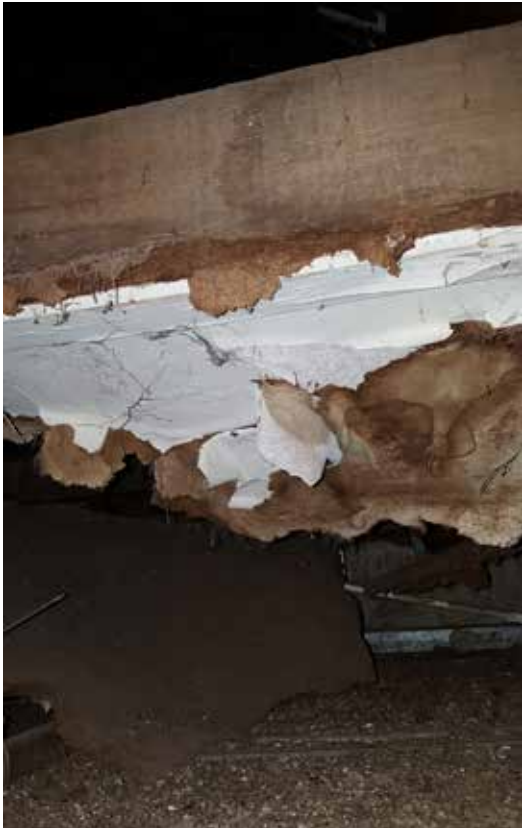
Suspended gypsum board ceilings are in fair to poor condition, with some water damage. They are concealing the historic construction and change the character of the rooms by significantly lowering the ceiling height. The original ceilings above (in Rooms 1 and 2) are in very poor condition, but could not be completely evaluated for lack of access.

*Old Ceilings*

Remove suspended ceiling in Rooms 1 and 2. Re-evaluate earlier ceiling materials. Most likely they will require replacement. If allowable by the building official, use similar light weight fiber board material such as Homasote with battens over the seams,

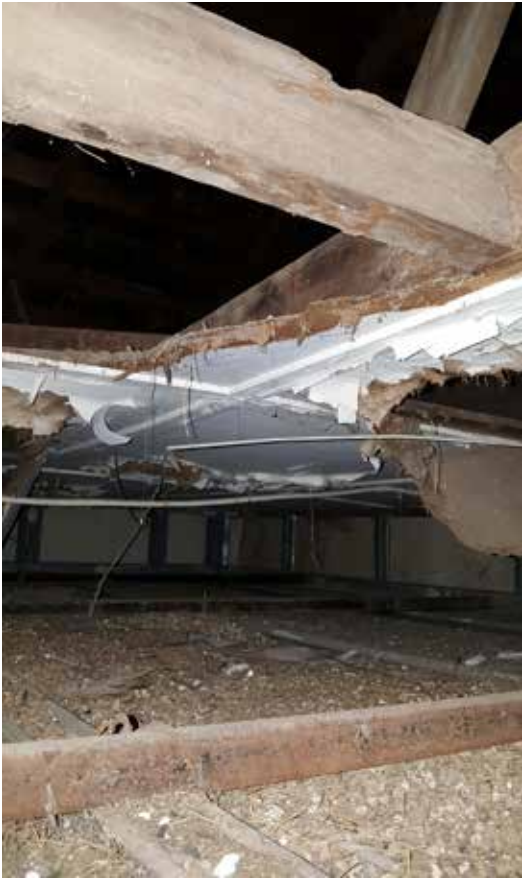
*Old Ceilings*

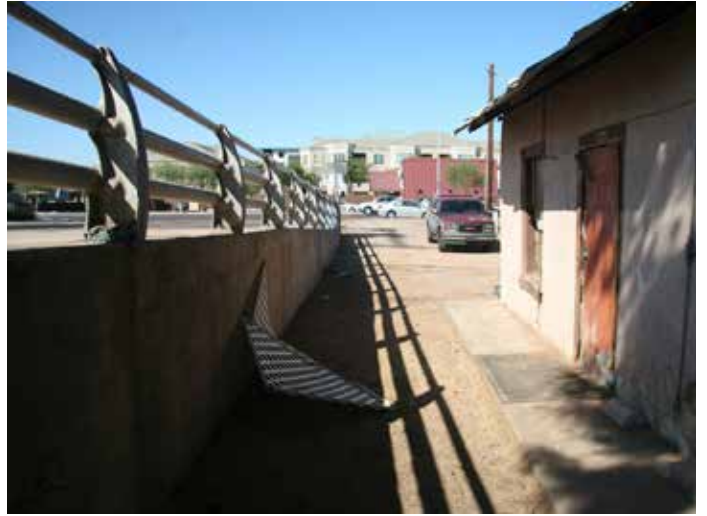
Areas of potential water retention close to adobe and wood foundation walls exist along the east and south sides of the house.

*South Yard to West*

Conduct a detailed topographic survey for the site in order to verify drainage patterns. If found to be necessary, re-grade the site to eliminate any standing water within 10 feet of the exterior foundation walls.
